SDDOT/SDLTAP Gravel Road Experimental Project Update

Ken Skorseth, SDLTAP Program Manager

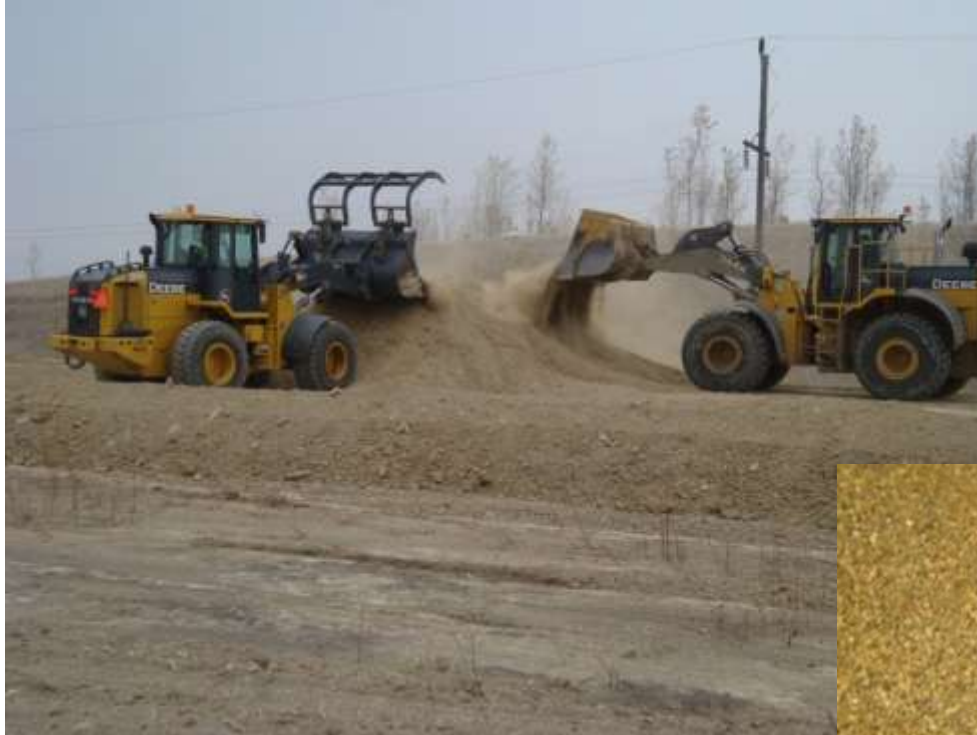
One way to meet modified spec – blend different material from separate sources

This was done on one section in Brookings Co and one section in Custer Co

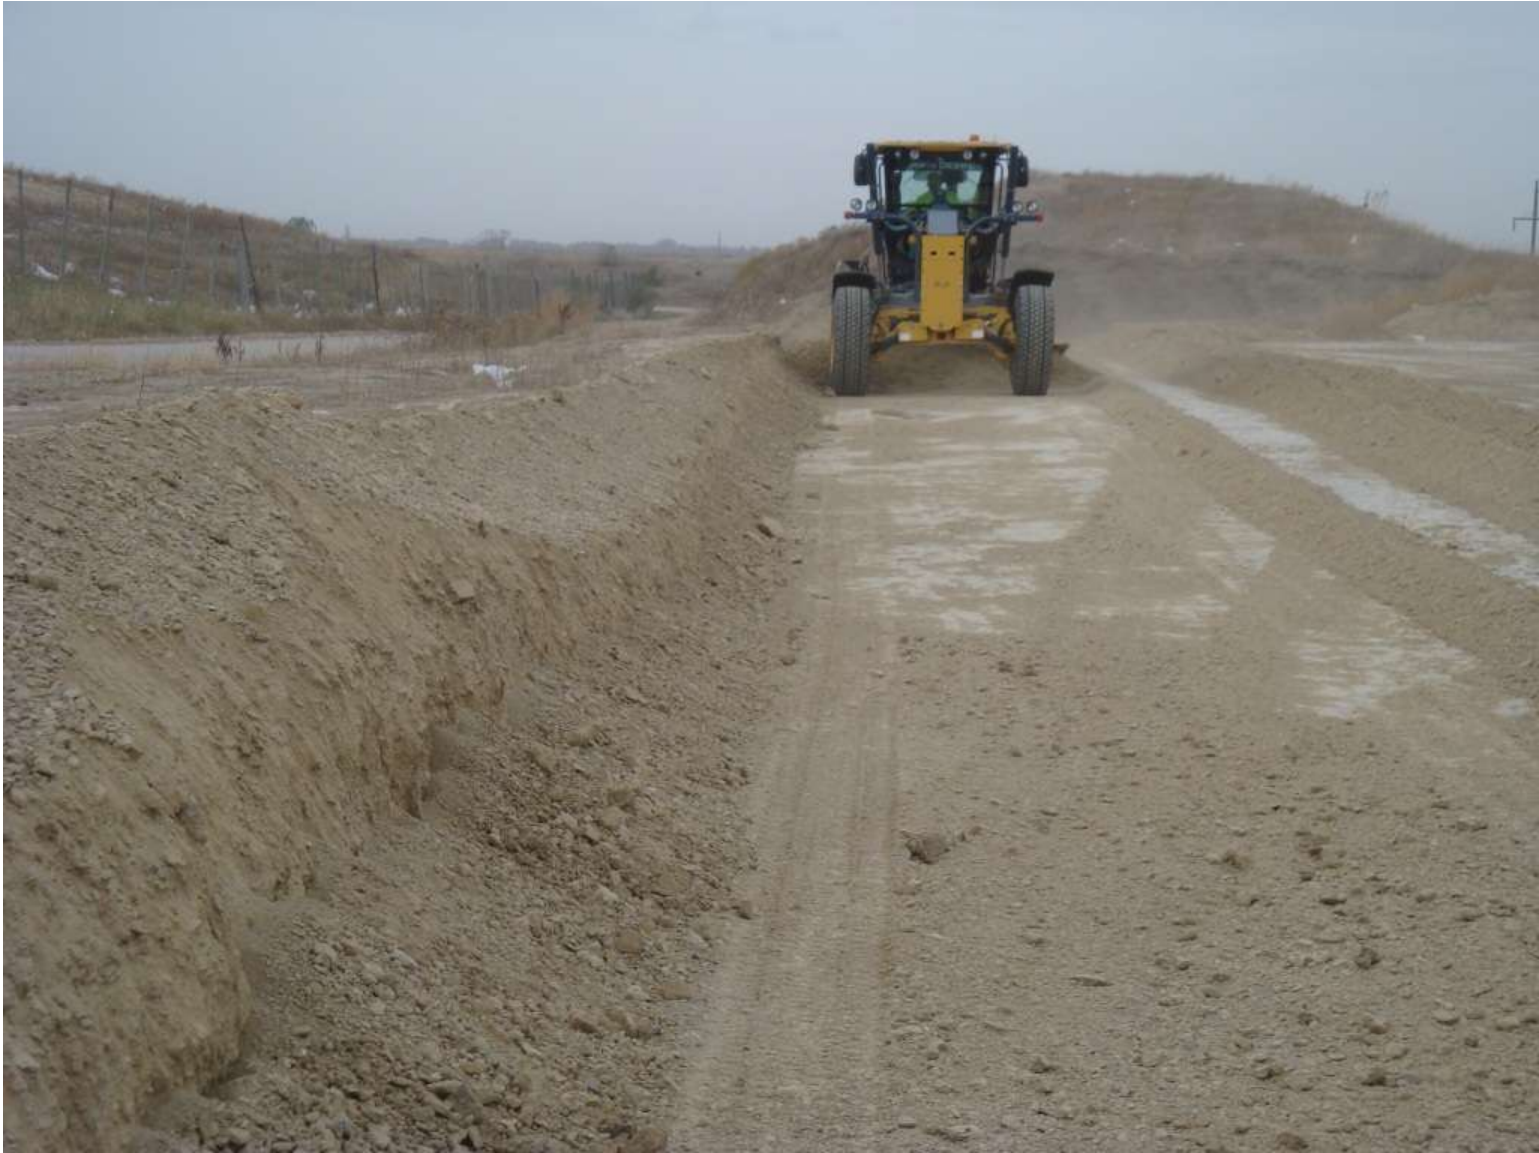
Is this the future? More blending or “manufacturing” to get high quality gravel – processing from a natural clay source here:

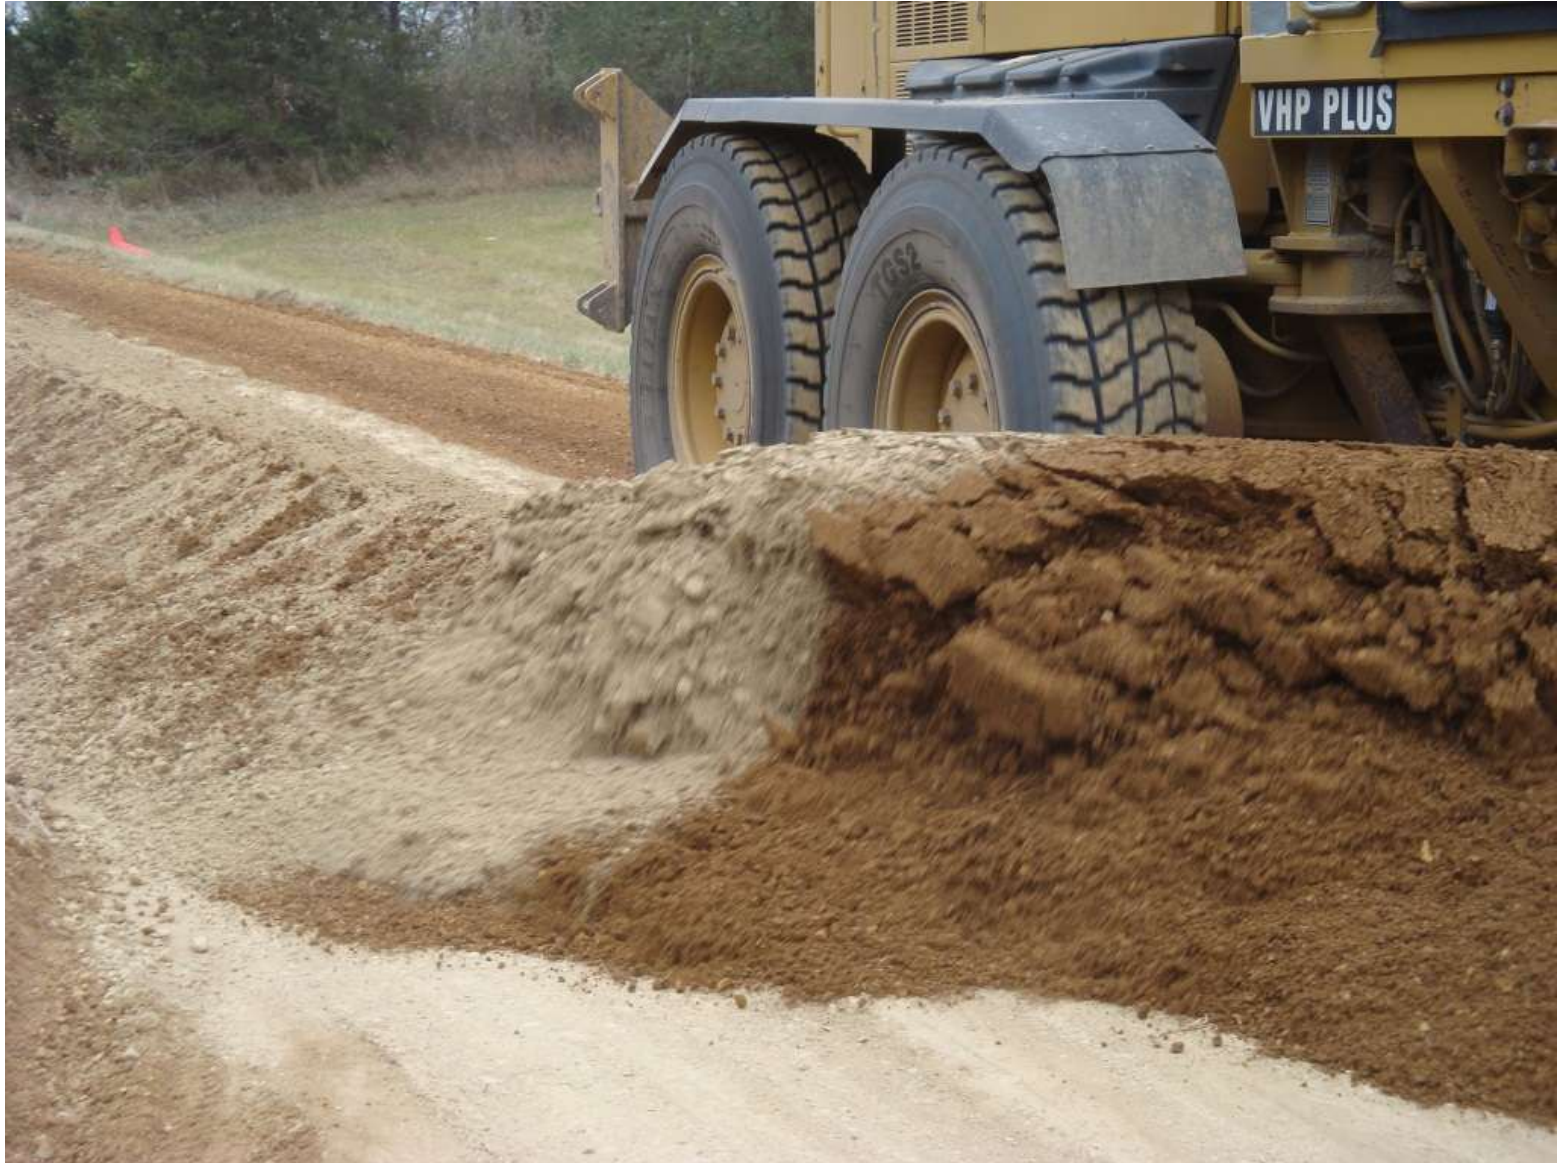
Road mixing natural clay to get a high quality surface gravel

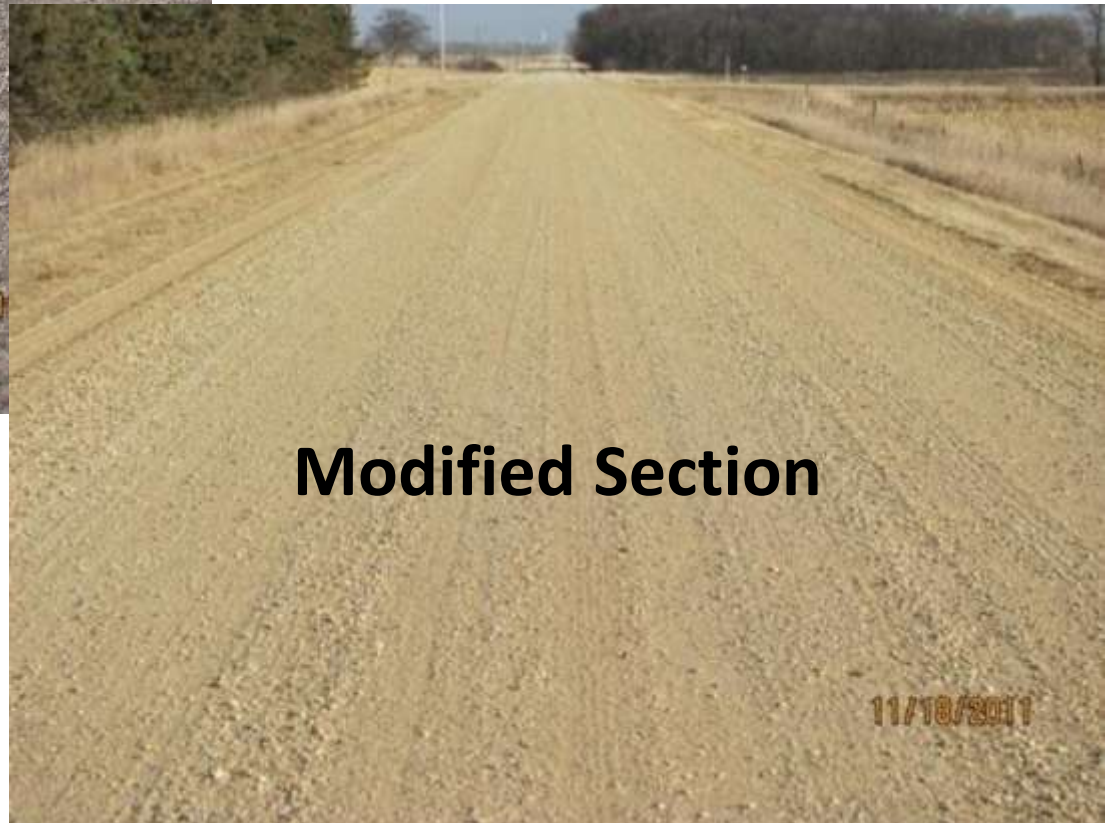
Substandard Section

Only one month after construction

Substandard gravel loosens in 31 days. Loose aggregate (or float) is 1 ¼ to 1 ½ inches between the wheel paths.

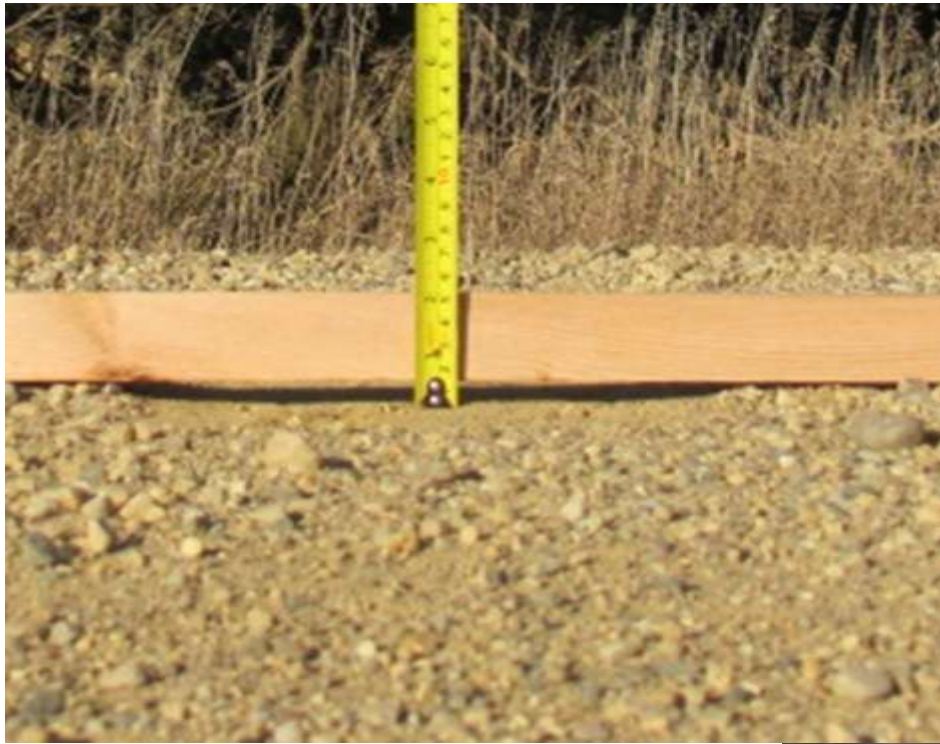
Modified Section

Modified material has only 1/4 to 3/8 inch of loose aggregate (float) between the wheel paths in the same 31 days.

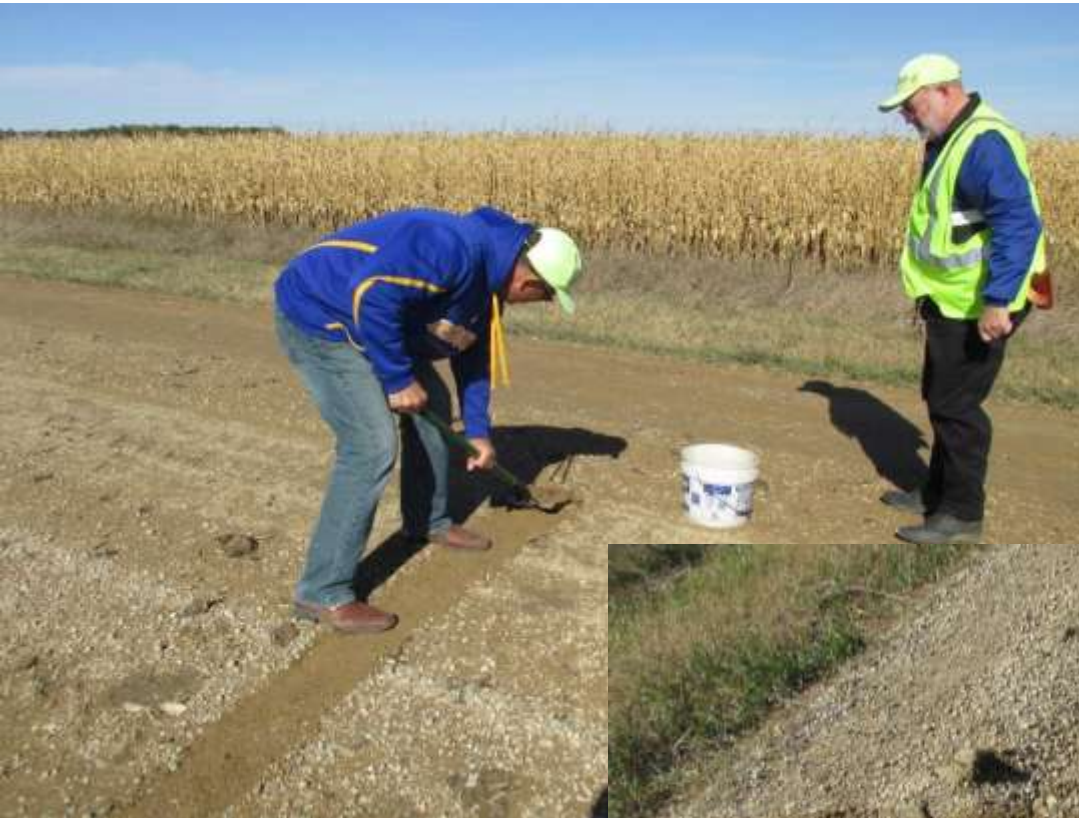
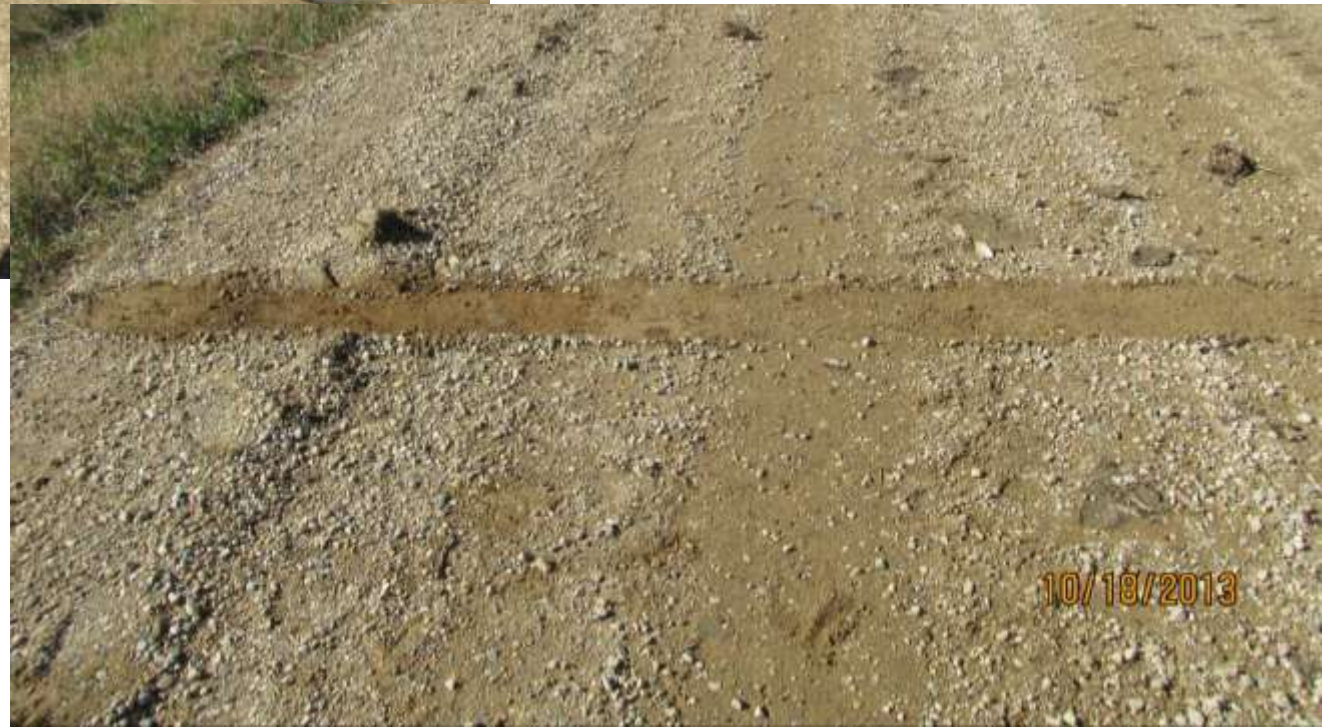
The float test (loose aggregate)

Simply remove loose aggregate from a 10 inch cross section, weigh it and convert that to a one-mile section

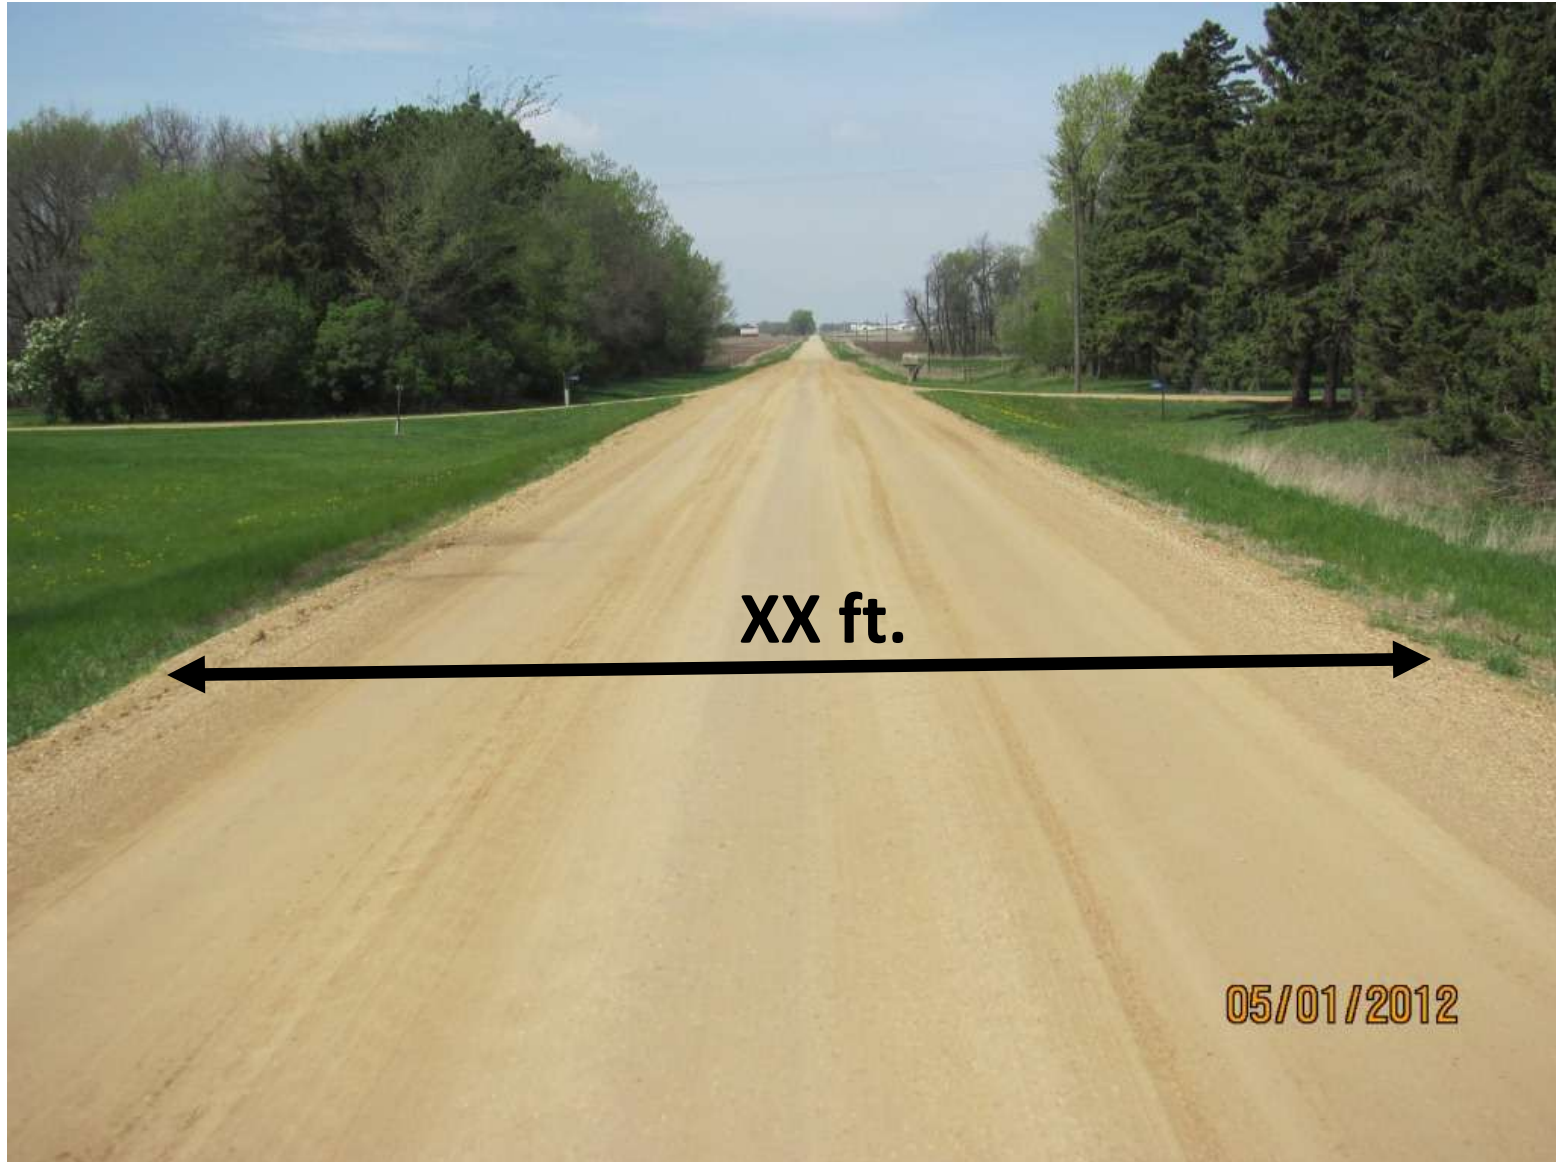
Change in top-width is measured on traveled way – hinge point to hinge point

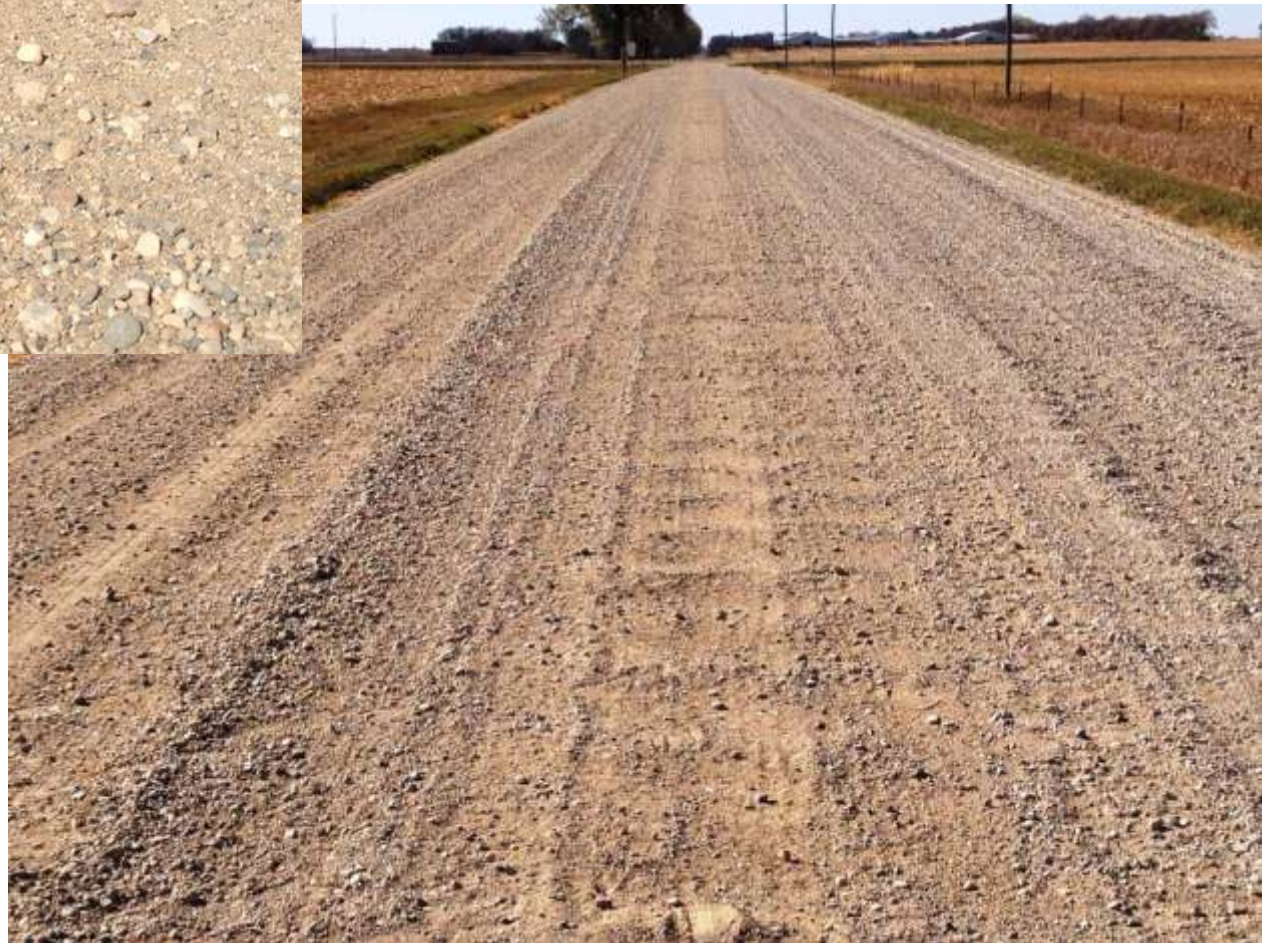
Corrugation (washboard):
Hard to quantify in extent,
fairly easy to measure severity

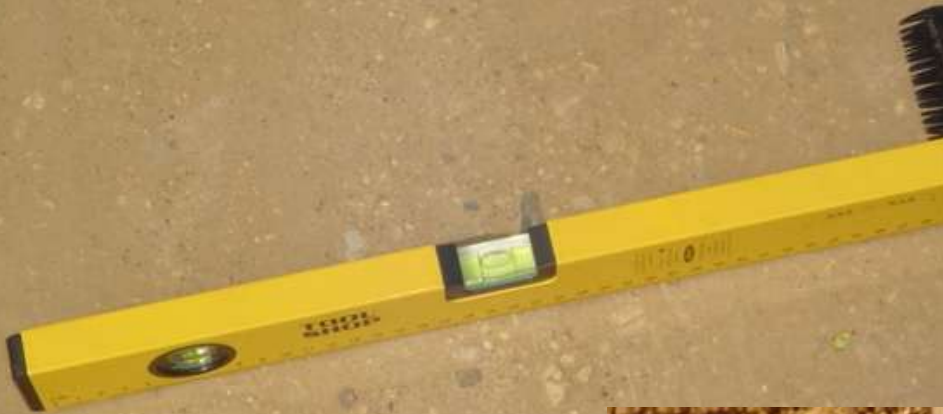
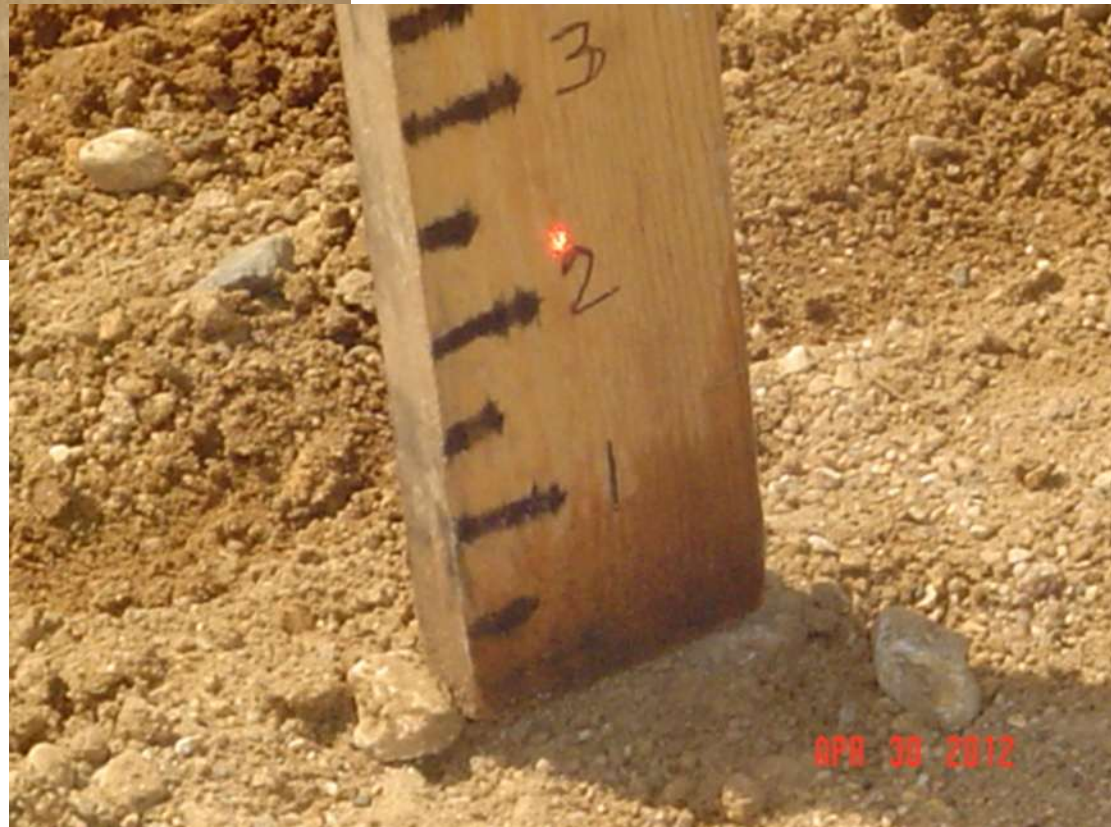
Crown:
measured with a
laser level

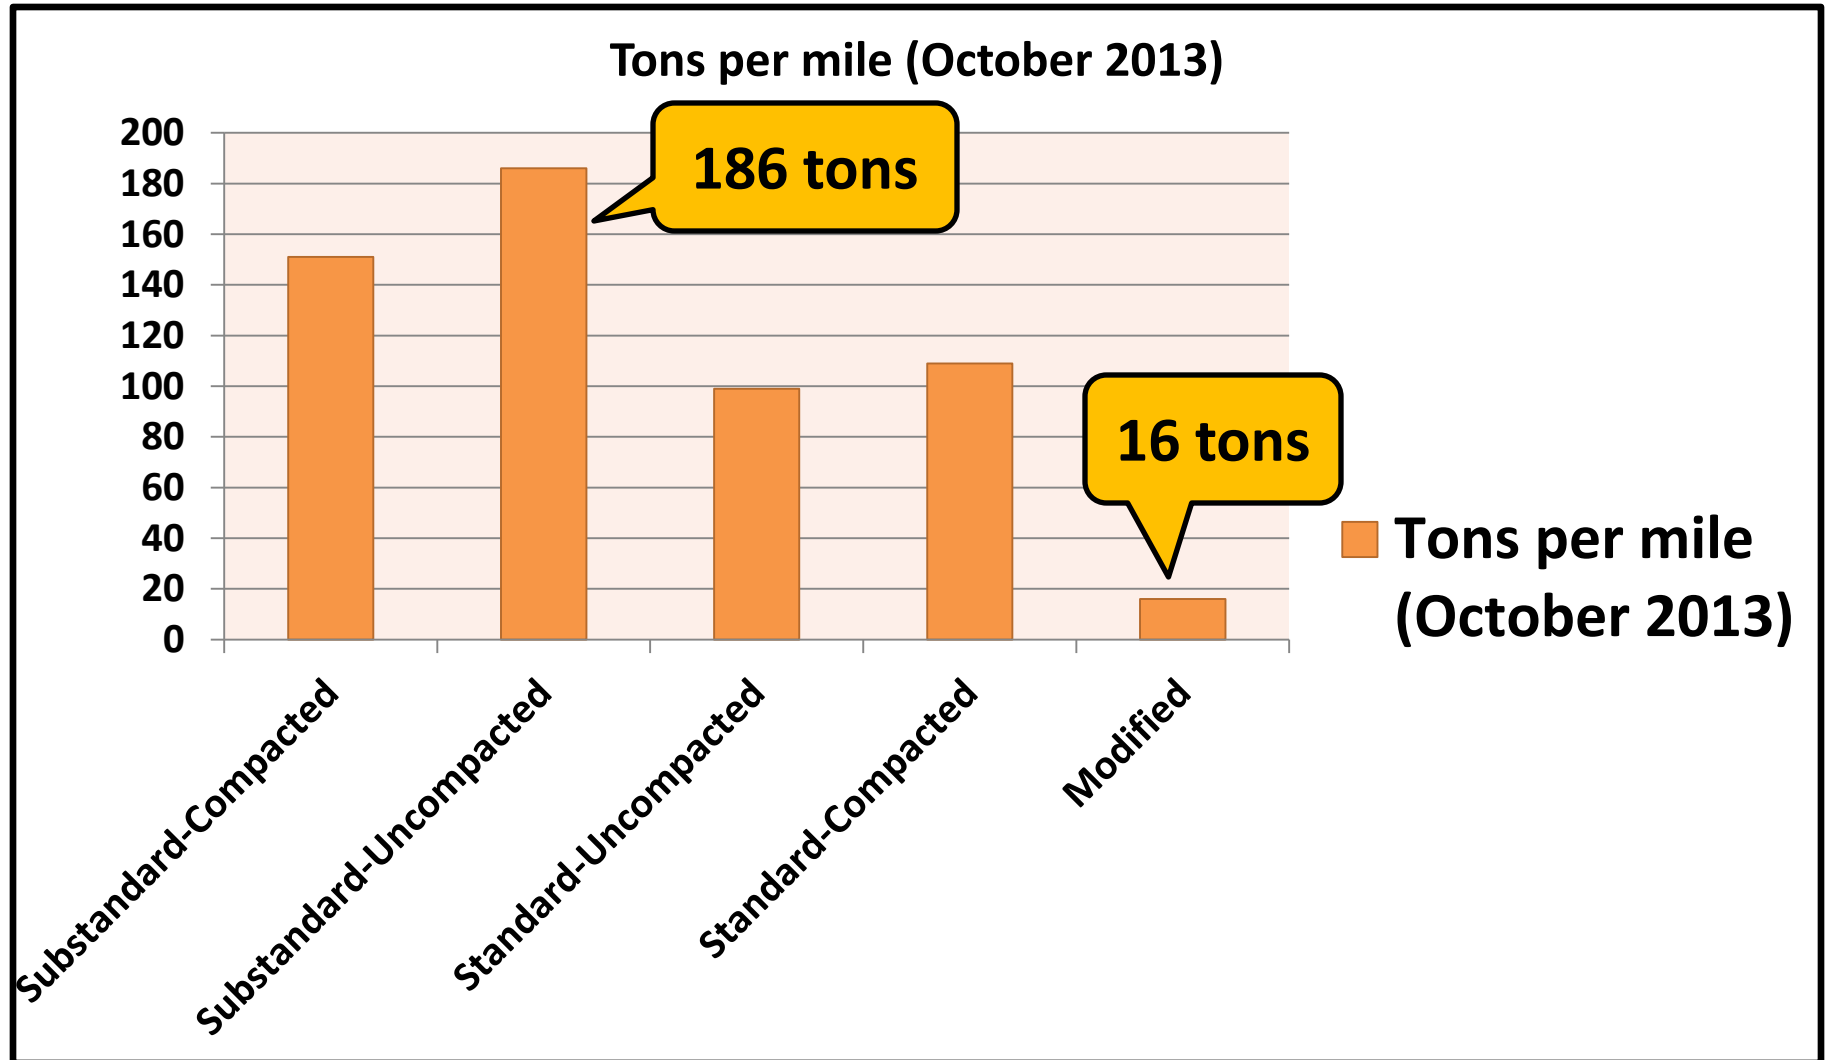
Brooking Section – Loose aggregate 2013

Cooler, wetter season in 2013 – 2.94 inches of rain in previous 20 days – most of that in three days prior to the last test.

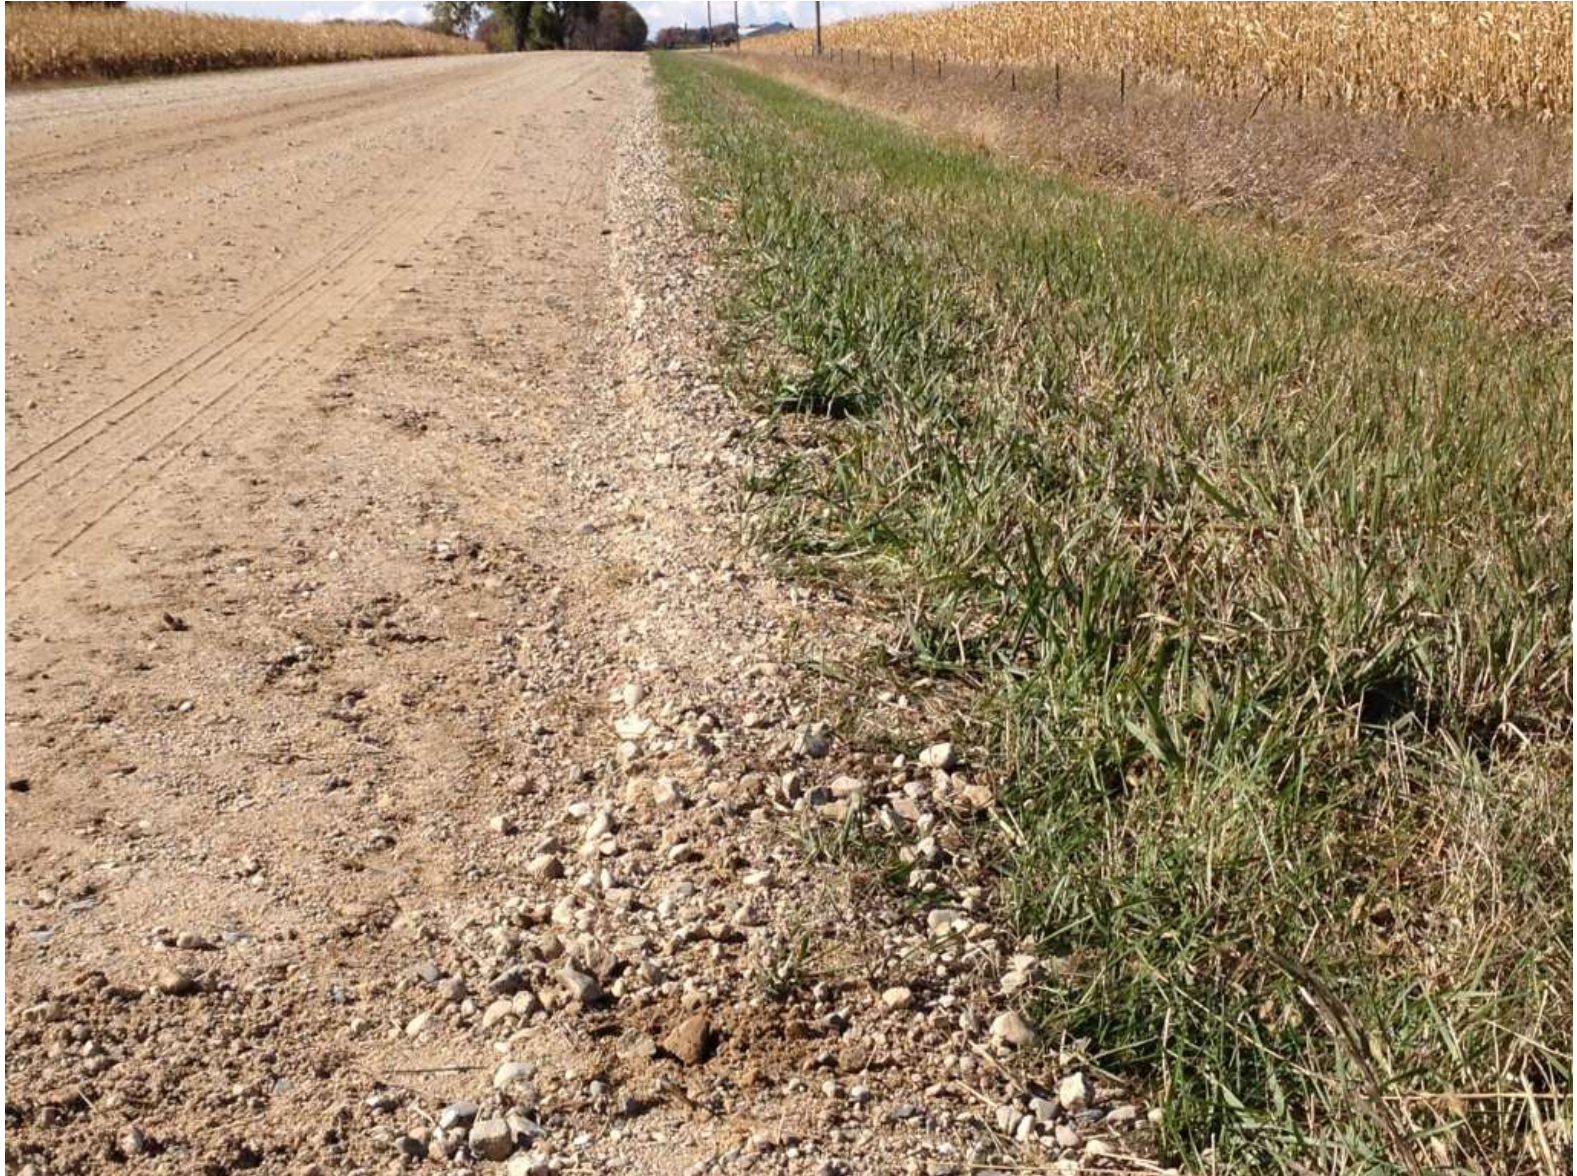
Substandard section – aggregate has moved outward over 4 ft since construction

Current width ranges from 22 ft on modified section (top bar) to 25.25 ft on substandard section (bottom bar)

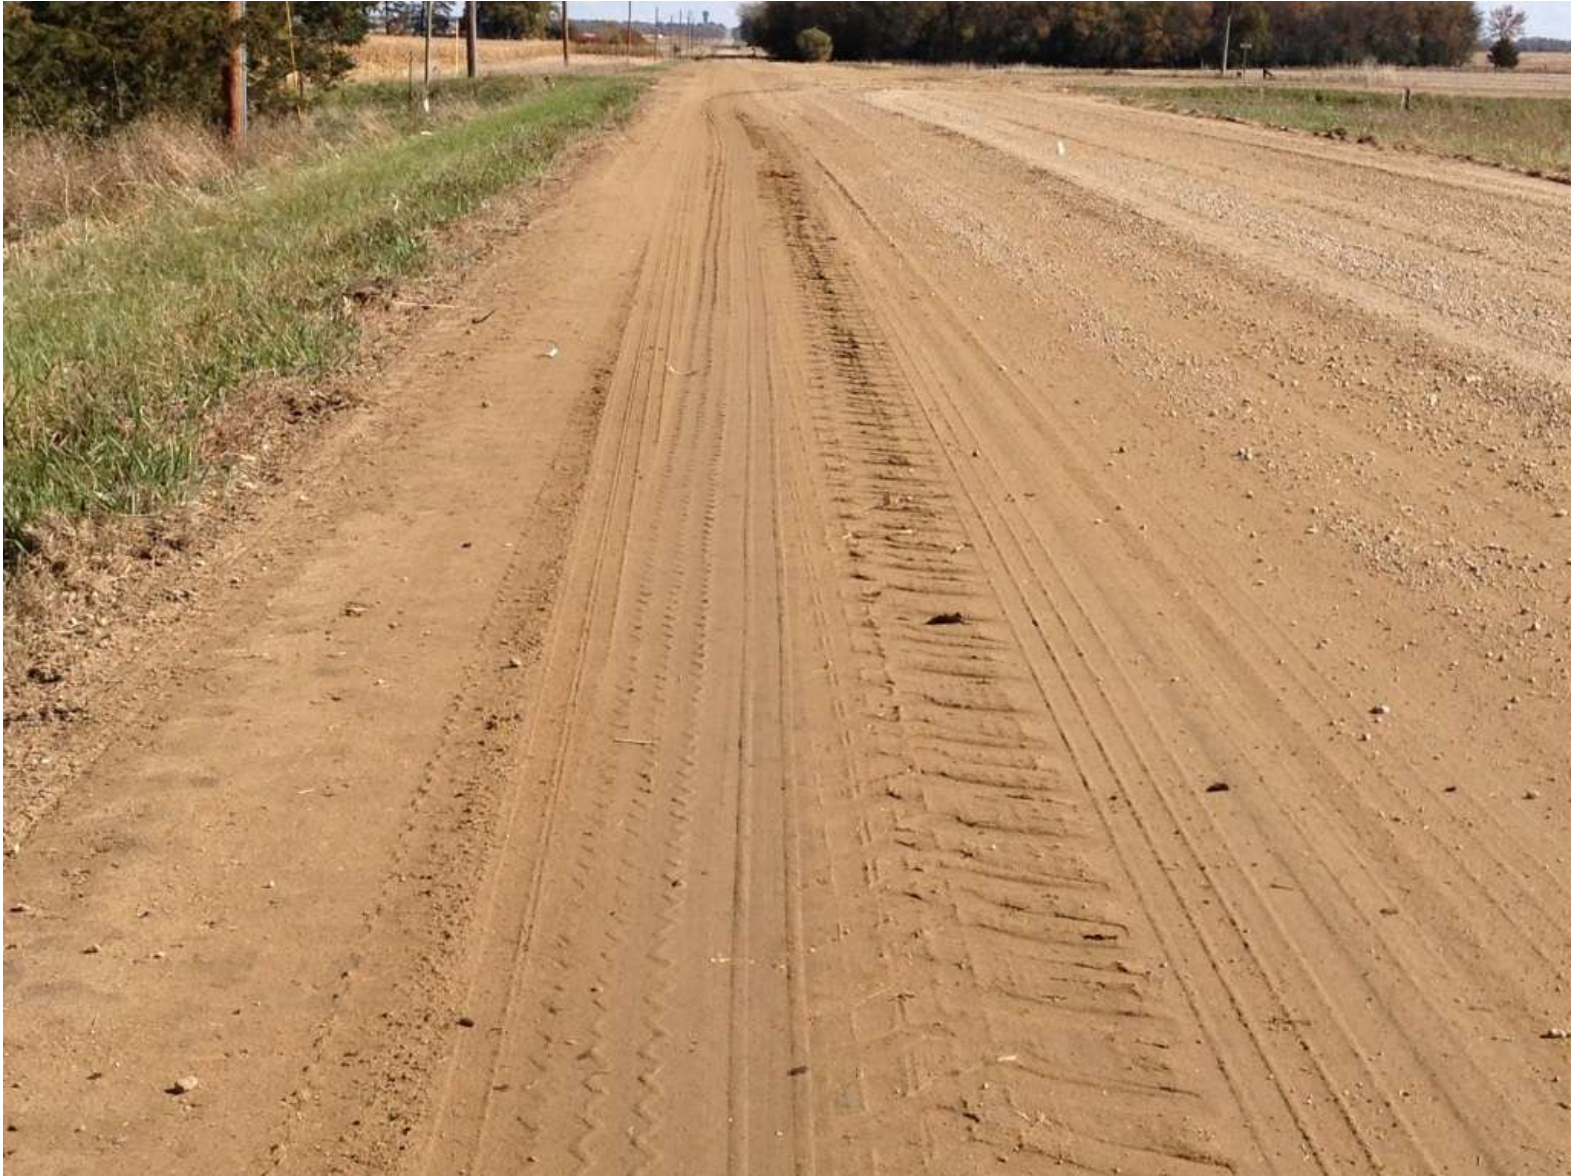
**Modified section has moved outward
only six inches since construction**

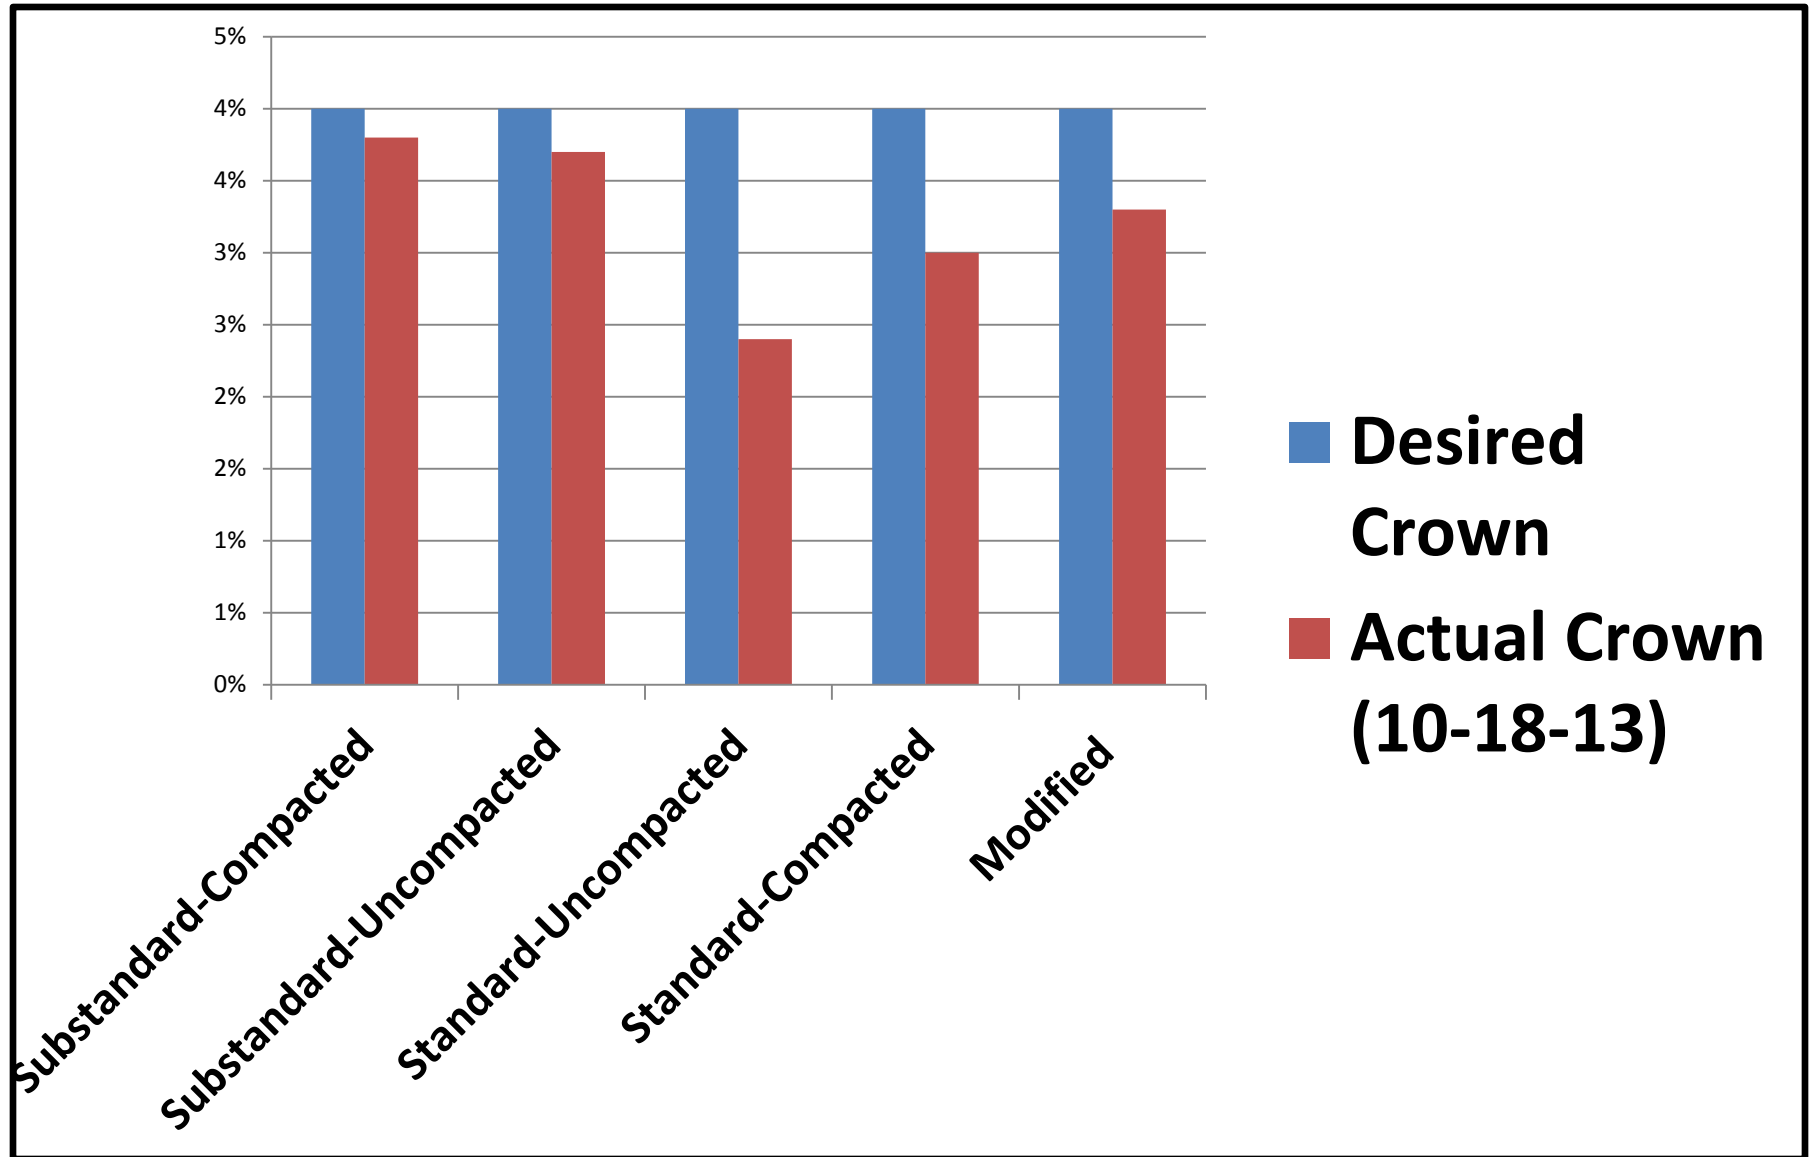
Problems with roadway crown

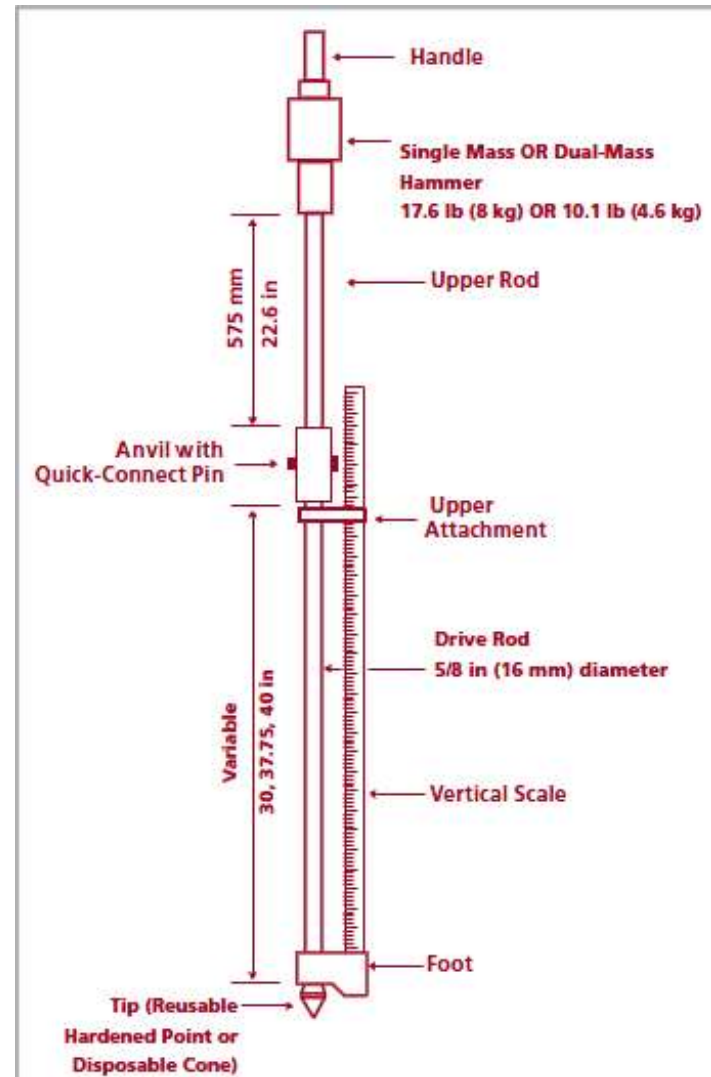
Dynamic Cone Penetrometer Testing

- Provide a measure of the in-situ strength of the base and subgrade
- A 17.6-pound weight is raised to a height of 1.8 feet and then dropped, driving the cone into the soil
- The variation in blows needed to drive the rod to a specified depth is an indicator of strength and stability of the subgrade

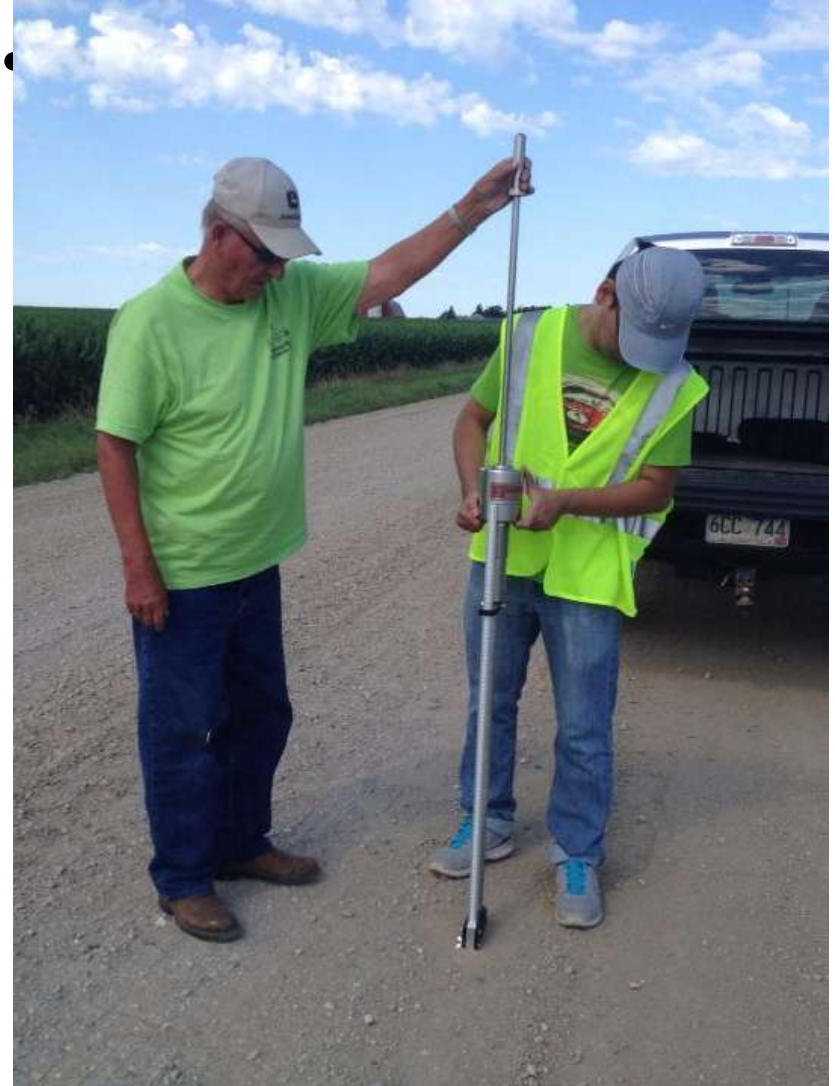
Field Use of Dynamic Cone Penetrometer

- Provide a measure of the in-situ strength of the subgrade
- A 17.6-pound weight is raised to a height of 1.8 foot and then dropped, driving the cone into the soil
- The variation in blows needed to drive the rod to a specified depth is an indicator of strength and stability of the subgrade

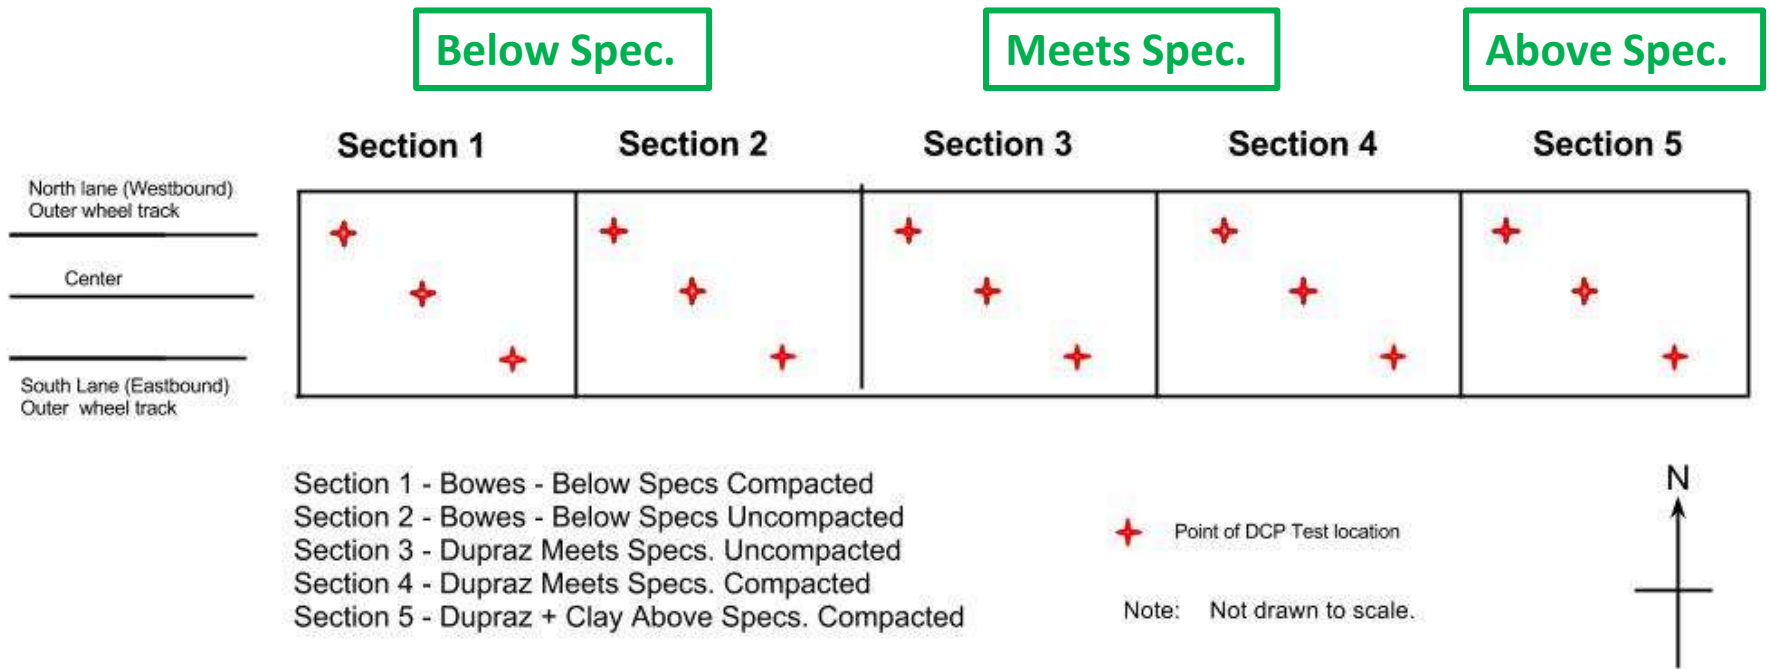
Test location layout

- **Brookings Co. Gravel Test Section (214th St.)**
