SDDOT/SDLTAP Gravel Road Experimental Project Update

Ken Skorseth, SDLTAP Program Manager

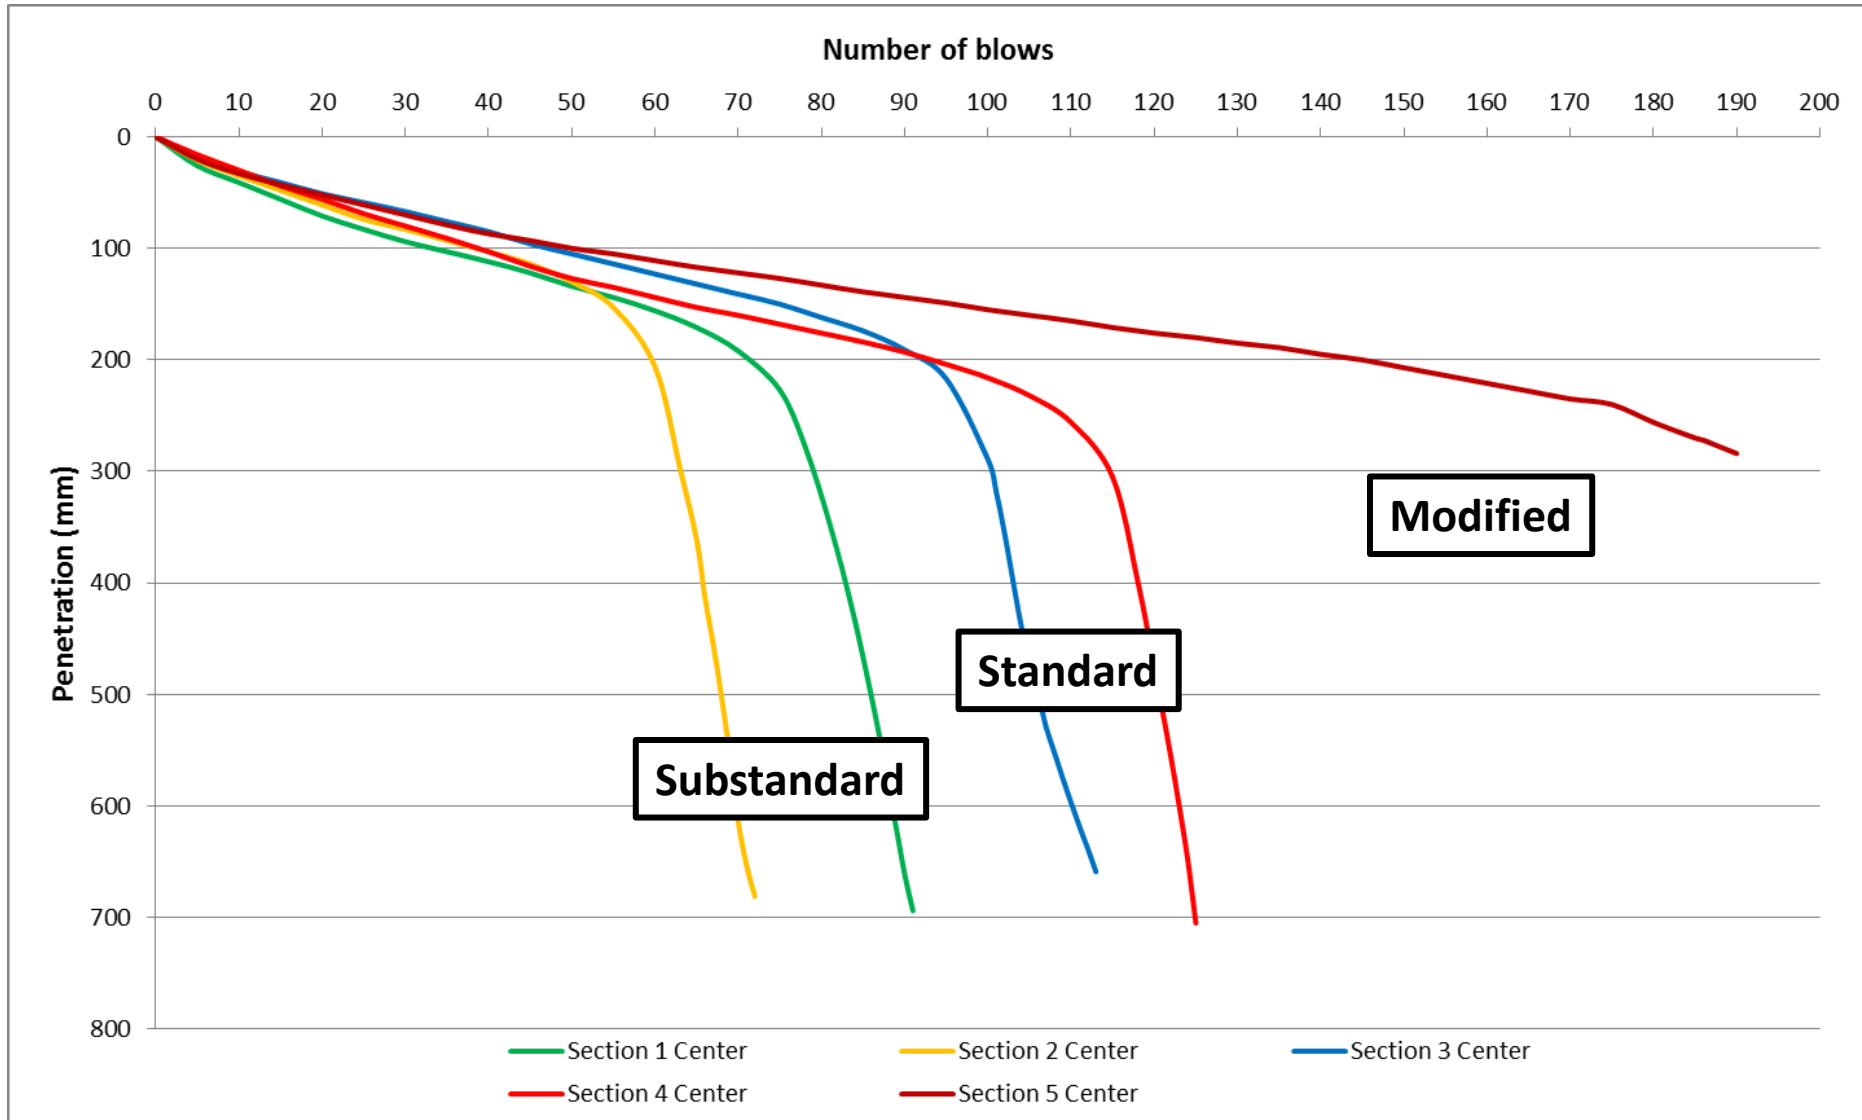
DCP Results

Different trend in strength in modified section:

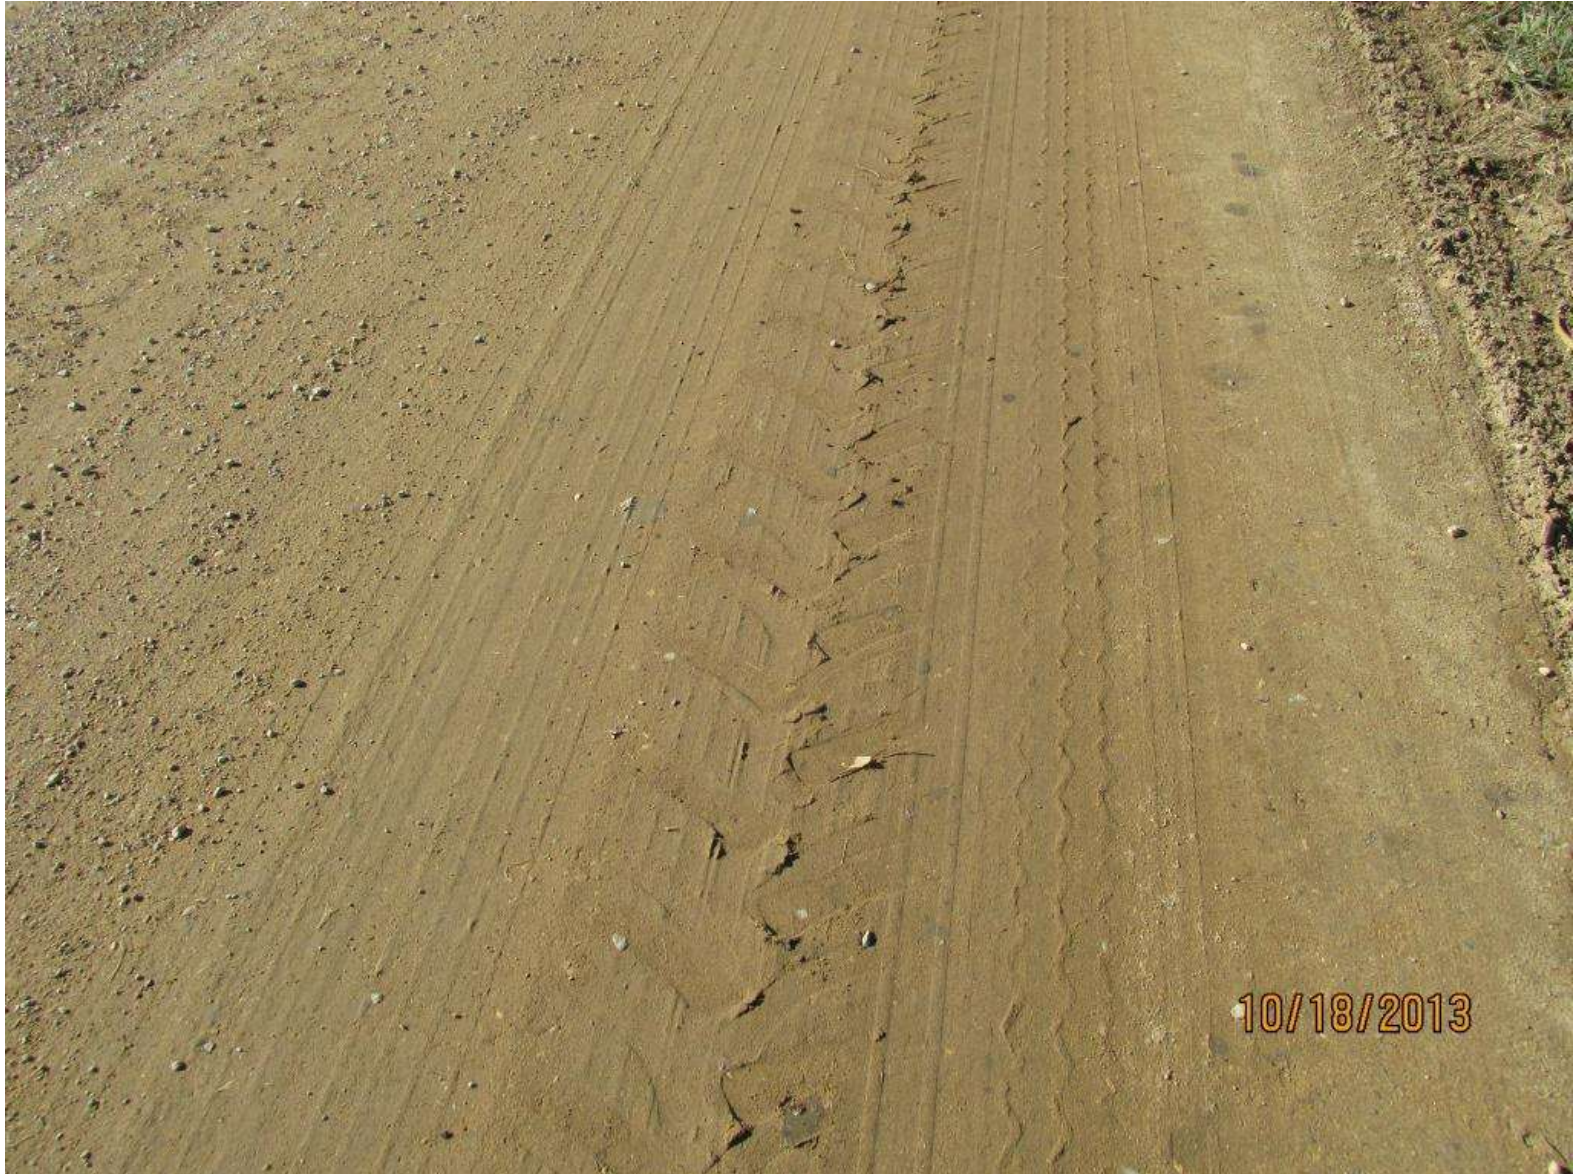
Does the modified section rut in wet weather? No, virtually no rutting observed.

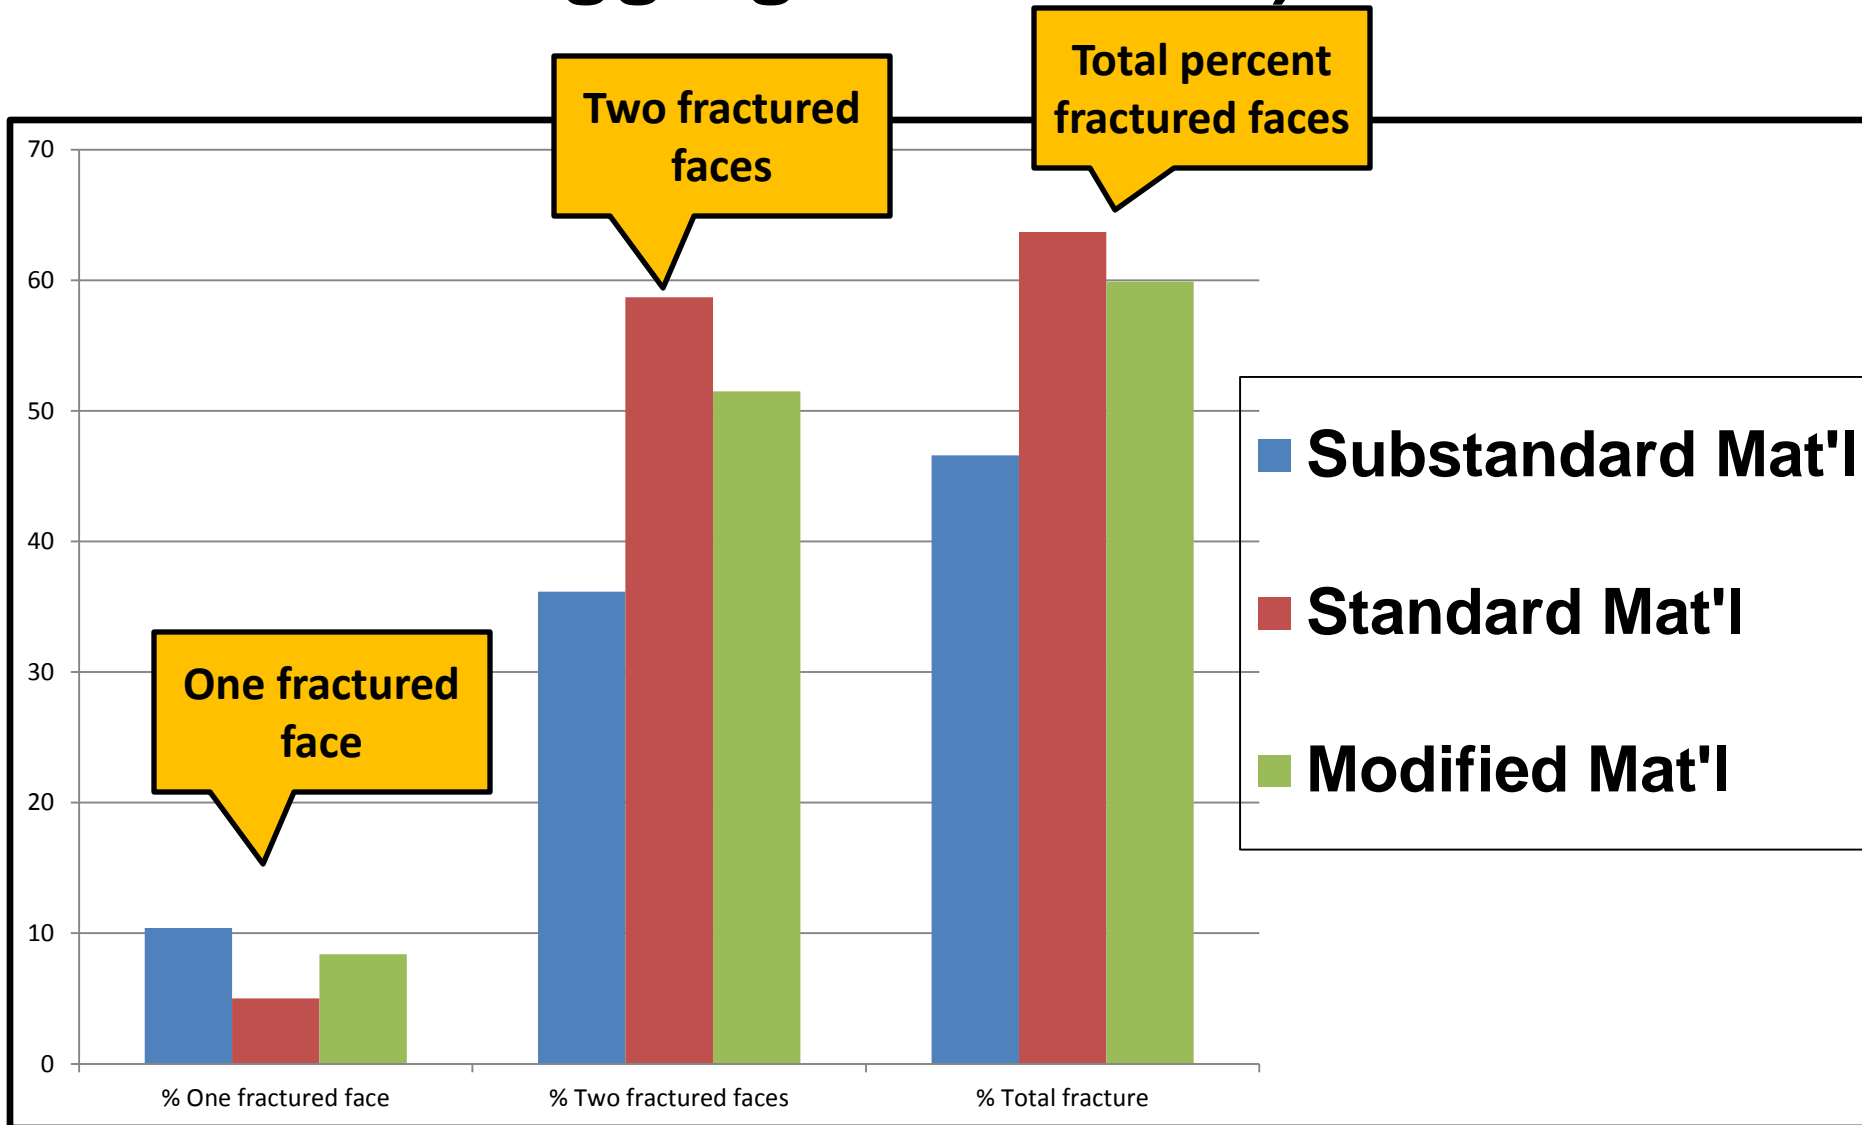
Percent of fracture of stone (natural aggregate sources)

Material Type	Percent fractured faces
Substandard – one inch top size control	2FF=36.15% 1FF=10.4% Total=46.6%
Standard – three-quarter inch top size control	2FF=58.7% 1FF=5.0% Total = 63.7%
Modified – three quarter inch top size control	2FF=51.5% 1FF=8.4% Total = 59.9%
