2018 YOU SHOW US CONTEST
Sign Reflectivity Assessment Tool

COUNTY: Burke County Road & Bridge

DESIGNERS: Kenny Tetrault and Connie Howell

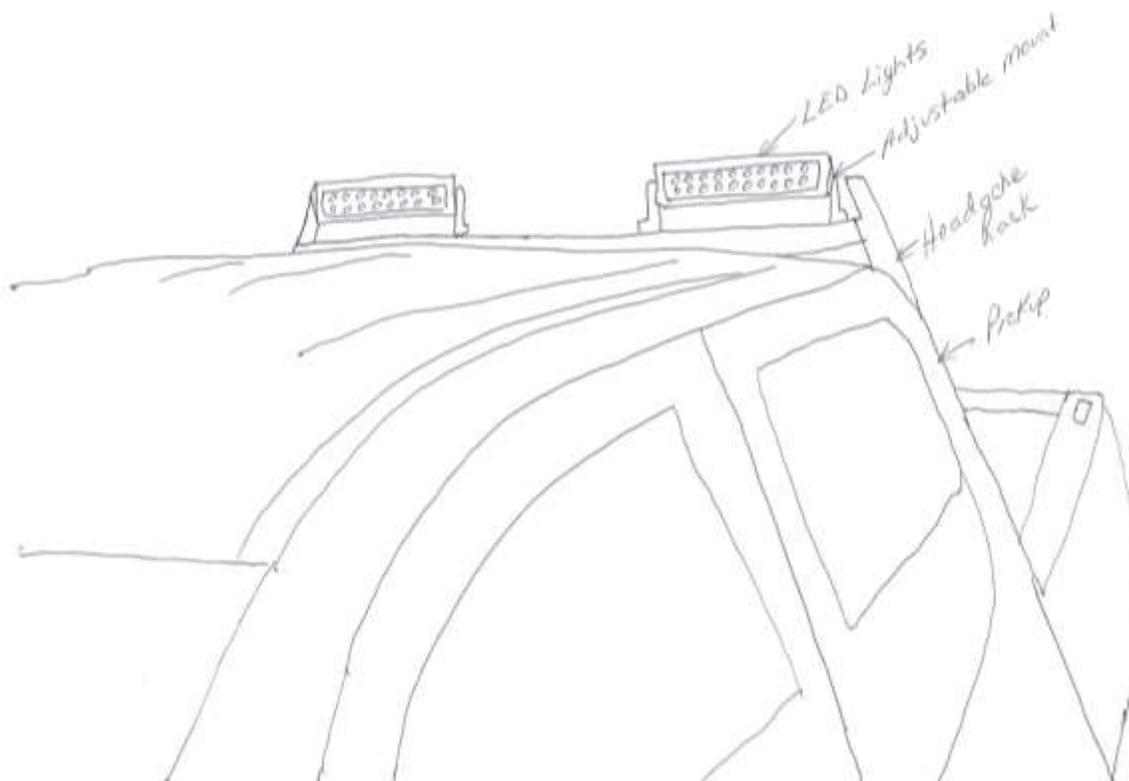
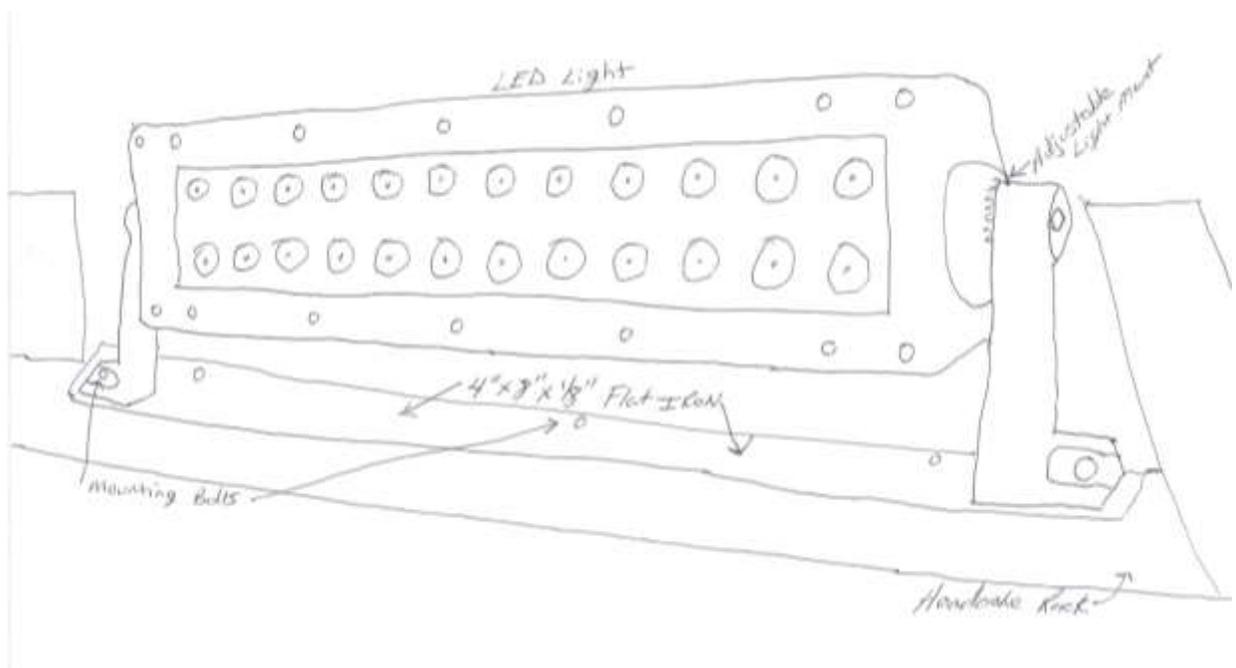
DRAWING (SCHEMATIC) WITH DETAILS:

Design and develop a tool and process so complete sign inspections can be done during normal daylight hours. We placed two high power LED lights with adjustable mounts on the headache rack of a pickup. By putting, a slight angle to the lights we are able to obtain better reflectivity results. We pulled electrical wiring from the LED lights into the pickup and installed an in-line switch so the driver can turn the lights on and off from inside the vehicle. The switch connects to the power supply with an in-line fuse or an auxiliary port in the fuse box.

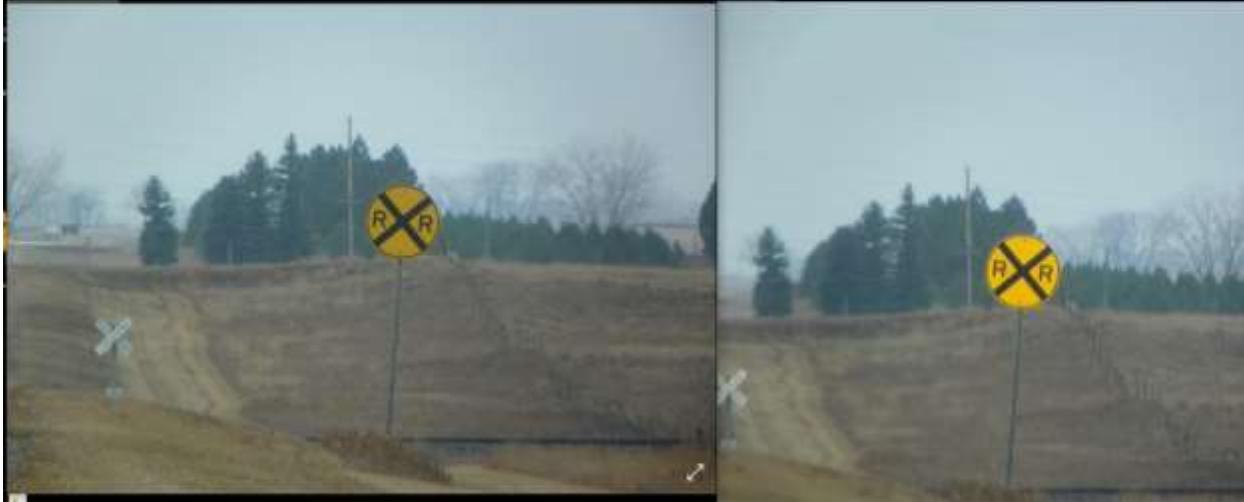
Before and after LED lights - comparison photos used to show sign reflectivity

We park the pickup between 50 to 75 feet from the road sign. From inside the cab, we take a picture of the sign using a digital camera. We then turn on the LED lights and take a picture of that same sign. When comparing the two photos, we are able to assess the reflectivity of the sign. The dated photos are up-loaded to the computer and stored in folders for their respective county road locations. Results become part of the sign inventory program.

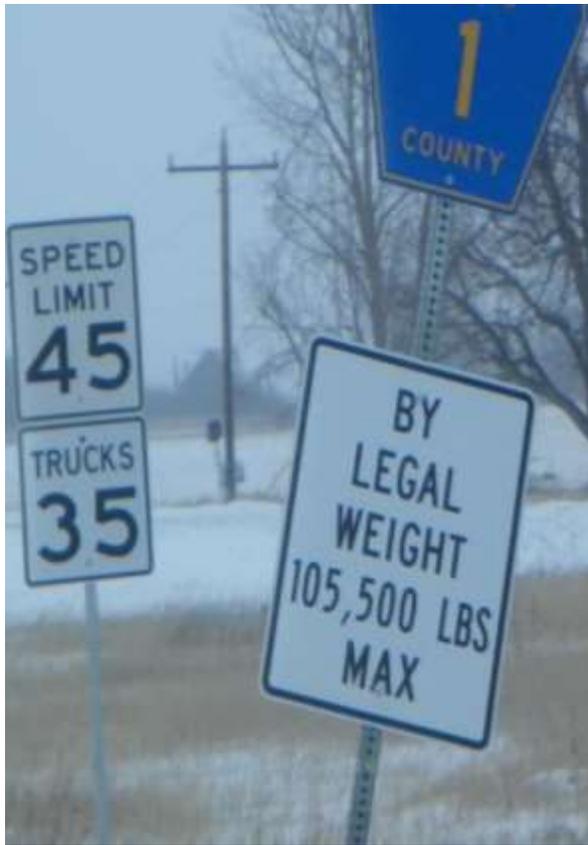
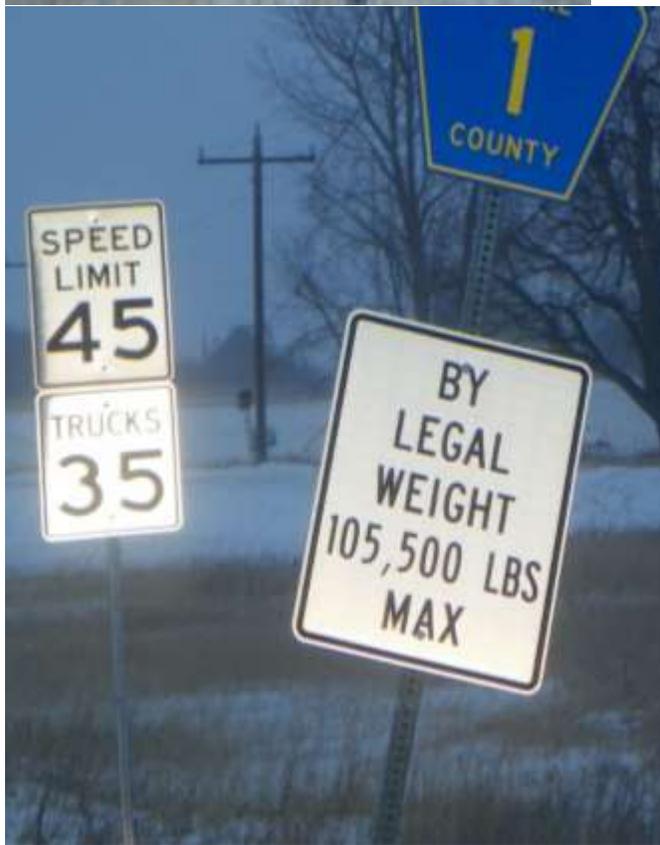
LED lights mounted on vehicle headache rack

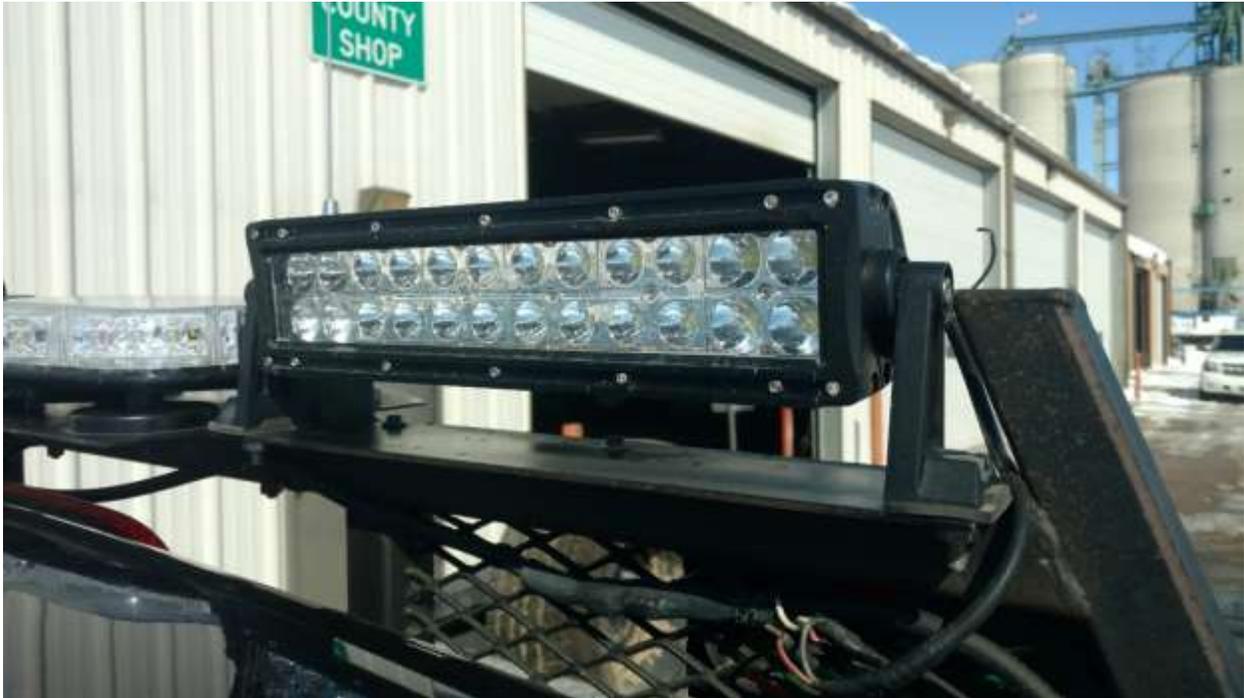
LED lights turned on to test sign reflectivity.

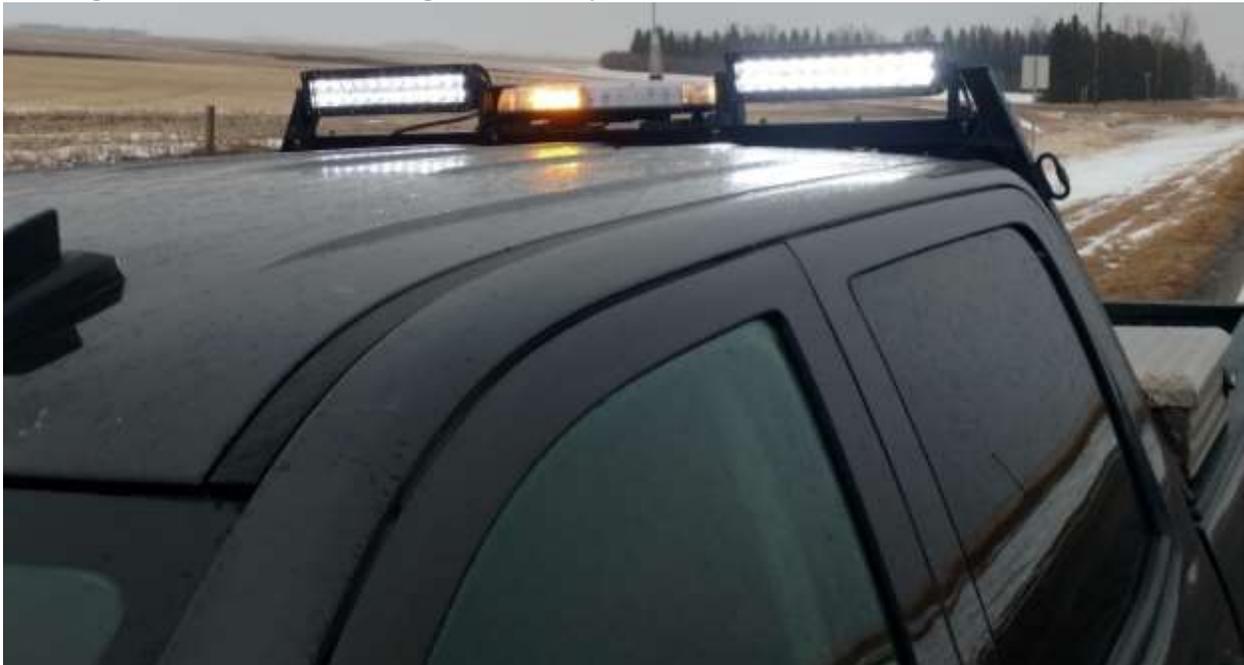
Photos taken with LED lights off, then on, to compare for sign reflectivity.
