Montana Basalt & North Dakota Class 13

BASALT ROAD MATERIAL INFORMATION

RE: John Detton Construction, Inc. Materials Testing Pioneer Technical Services Project No. 15665

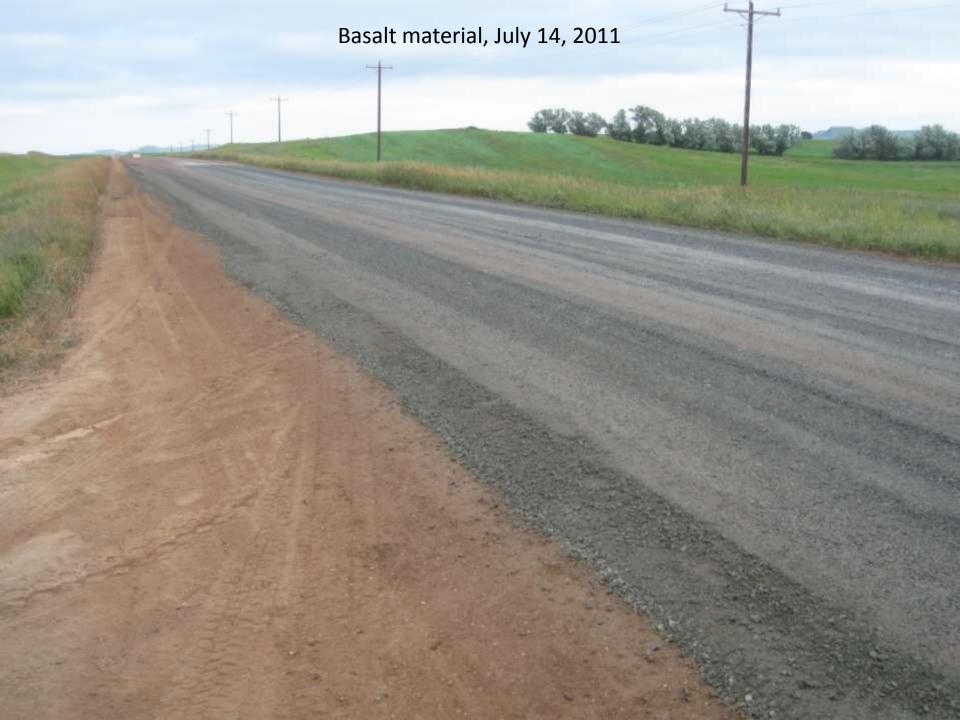
Basalt material, July 14, 2011

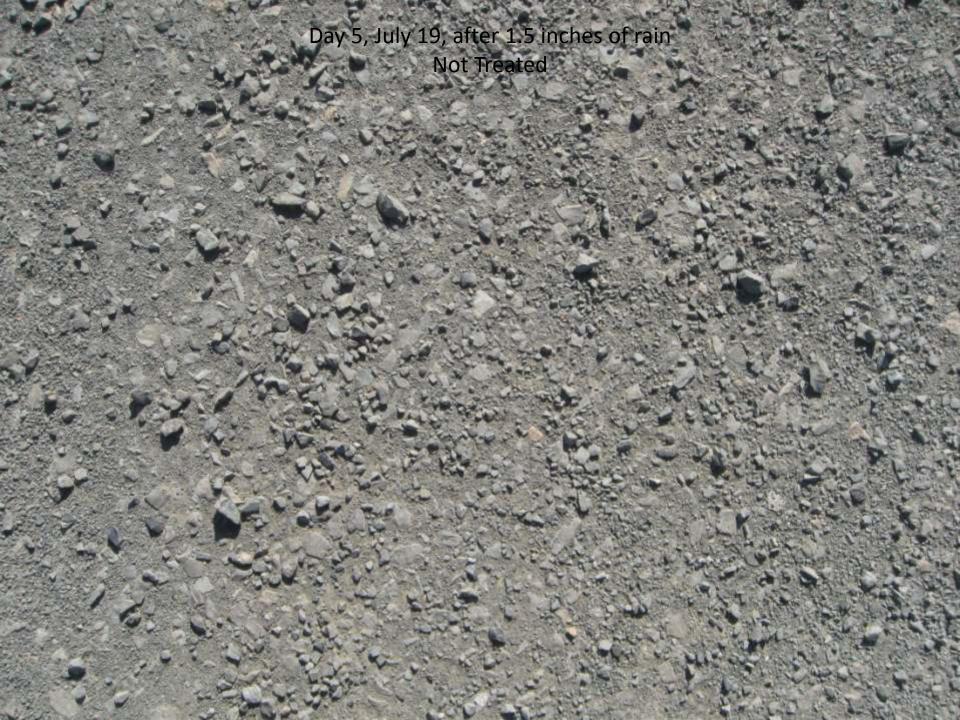
Day 5, July 19, after 1.5 inches of rain

Not Treated

Lots of segregation on shoulders
