YOU SHOW US CONTEST 2012

FHWA LTAP/TTAP
BUILD A BETTER MOUSETRAP
NATIONAL COMPETITION
National Entry Booklet 2012

National Better Mousetrap Winners

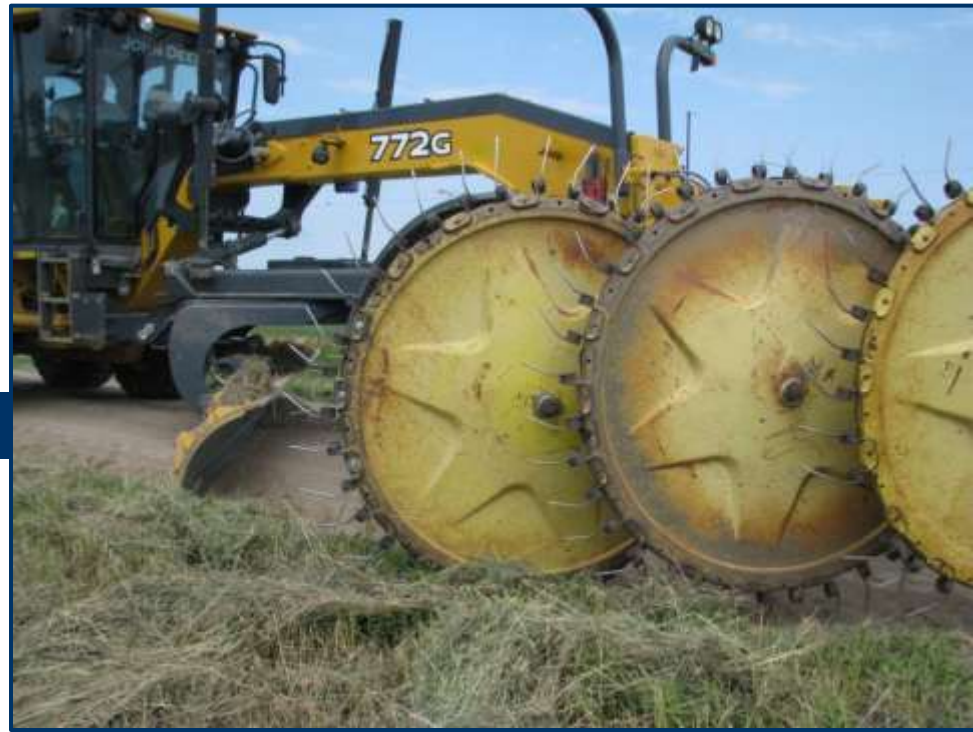
- Modified wheel rake to mount on front end of a motor grader to remove loose grass prior to road blading.
- Rake attaches to dozer blade with multiple adjustments for angle and height.
- Loose grass raked into the ditch blows away or deteriorates.

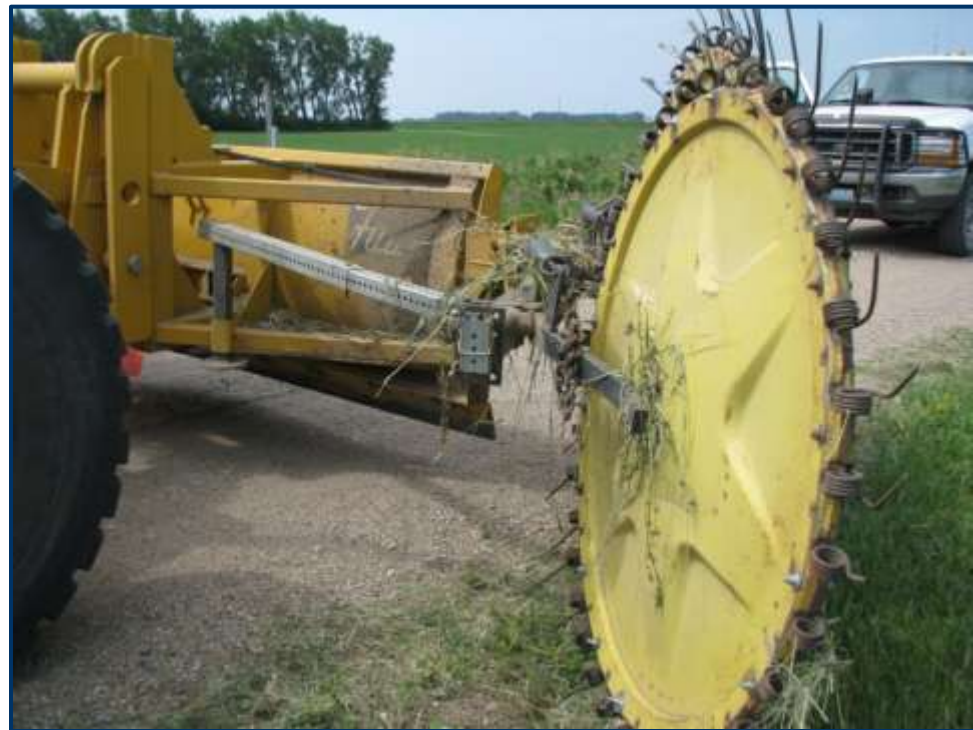
- Wheel rake discarded by local farmer = \$0
- Modifications: flat iron, telespar tubing, nuts & bolts = \$50.
- Labor: 2pp x 8 hrs x \$35/hr = \$280
- **Total cost: \$330**

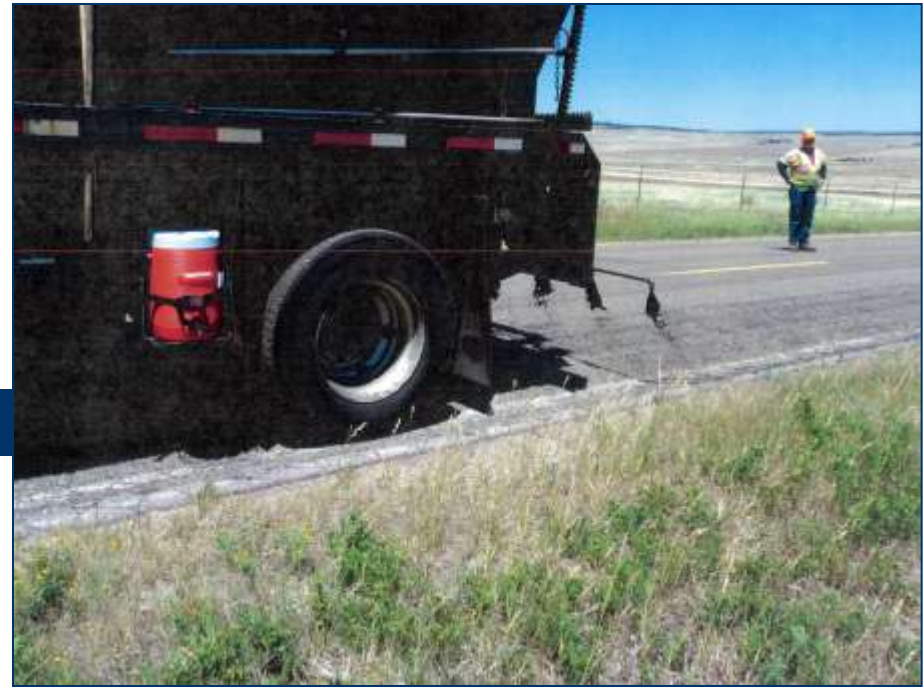
- A "spray-bar" that hung on back of asphalt patch truck, on lift arms for patch roller.
- The hand wand can be quickly disconnected, and hose attached to the spray-bar.
- Has several valves to control width of spray area
- Roller lift can raise/lower bar changing thickness of pattern
- Can all be turned on/off from inside cab while on move

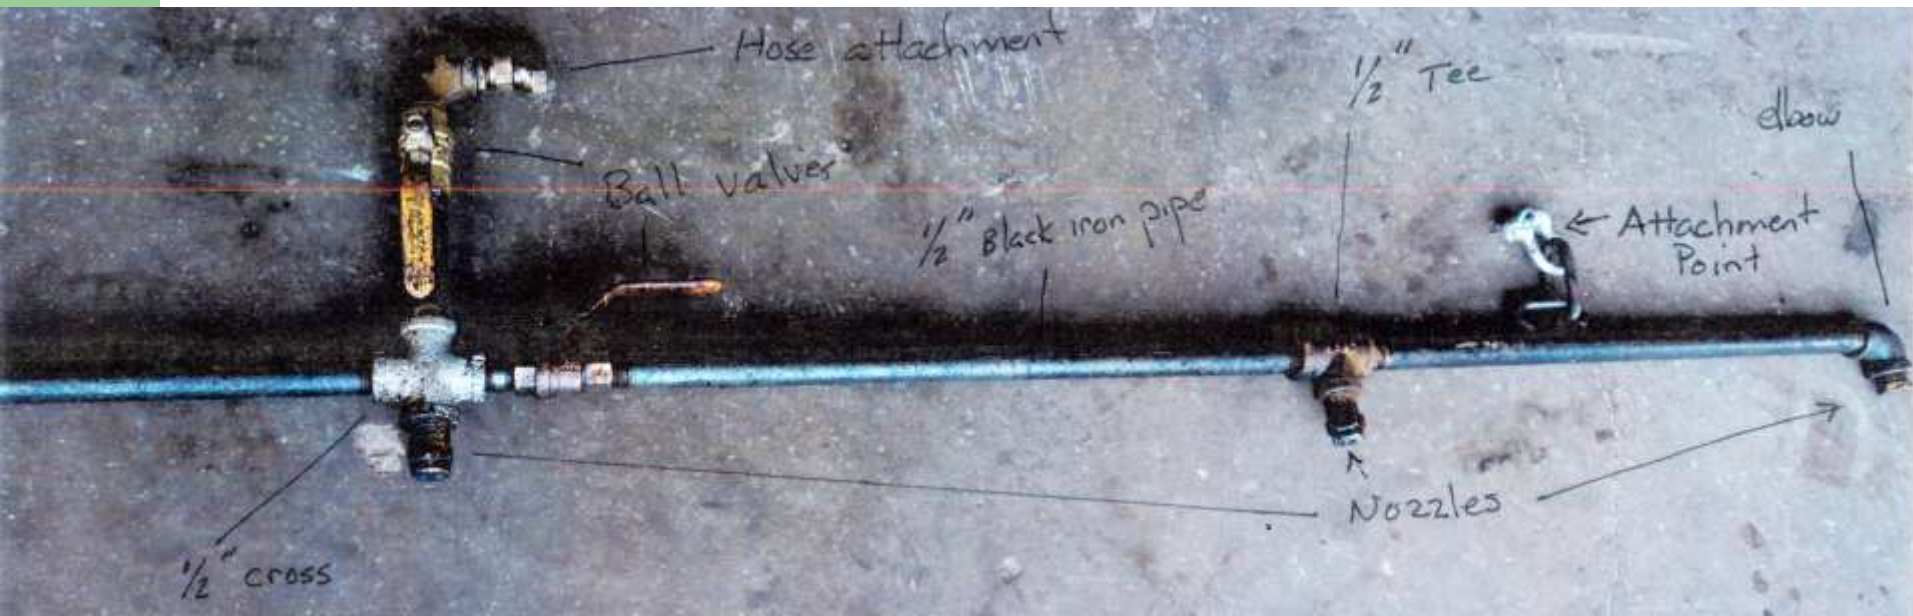
- Spray nozzles, 1/2" iron pipe, 1/2" tees, ball valves
- **Total Cost: ~ \$40**

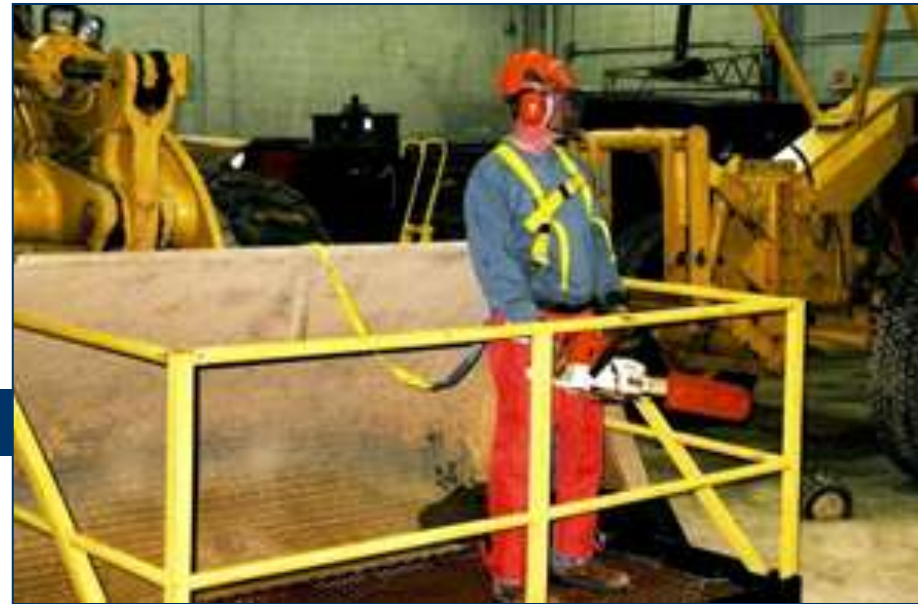
- A safety scaffold that mounts at front of loader bucket
- Railing surrounding front and sides of bucket
- Strong mesh floor for safety in preventing slips
- Safety harness and lanyard attached to a ring

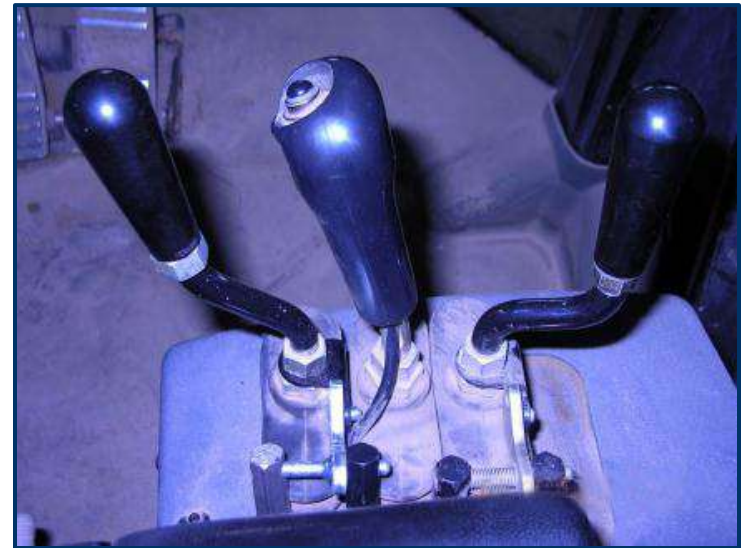
A locking device installed on loader controls in cab so bucket cannot be tilted or raised/ lowered while work is being done from bucket.

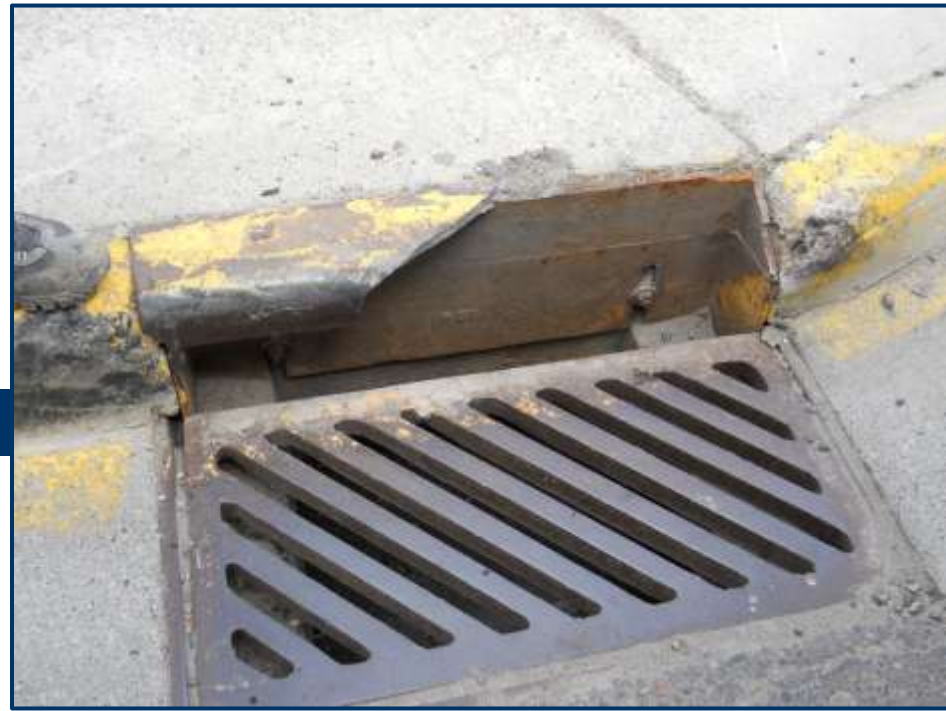
- Backing plates covering stormwater drains damaged by heavy equipment or struck by snow plows in winter
- Backing plates are required by City's Engineering Dept to protect debris from getting into stormwater drain systems
- Old method of replacing damaged plates required digging out old broken plates embedded in concrete

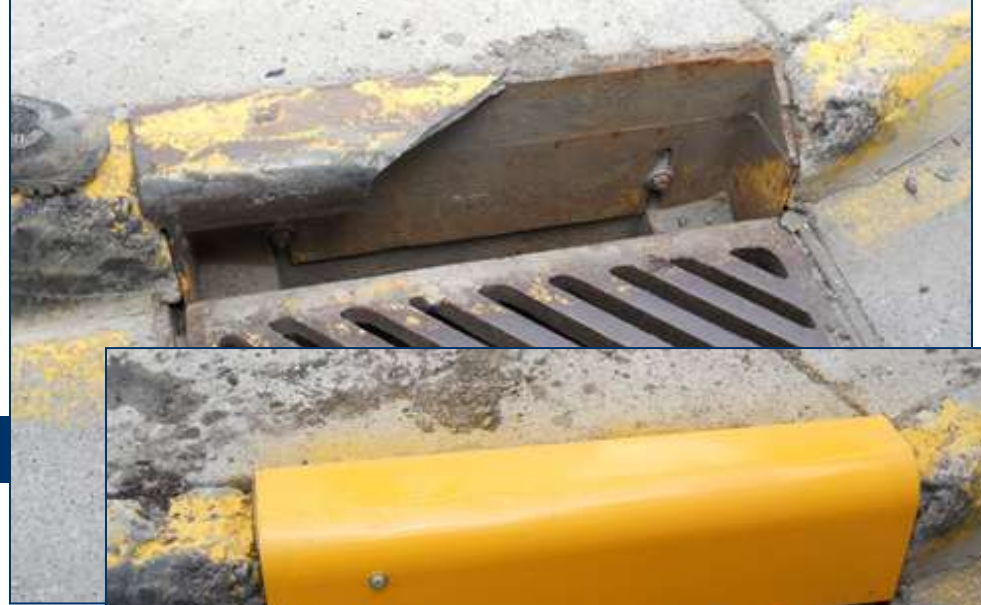
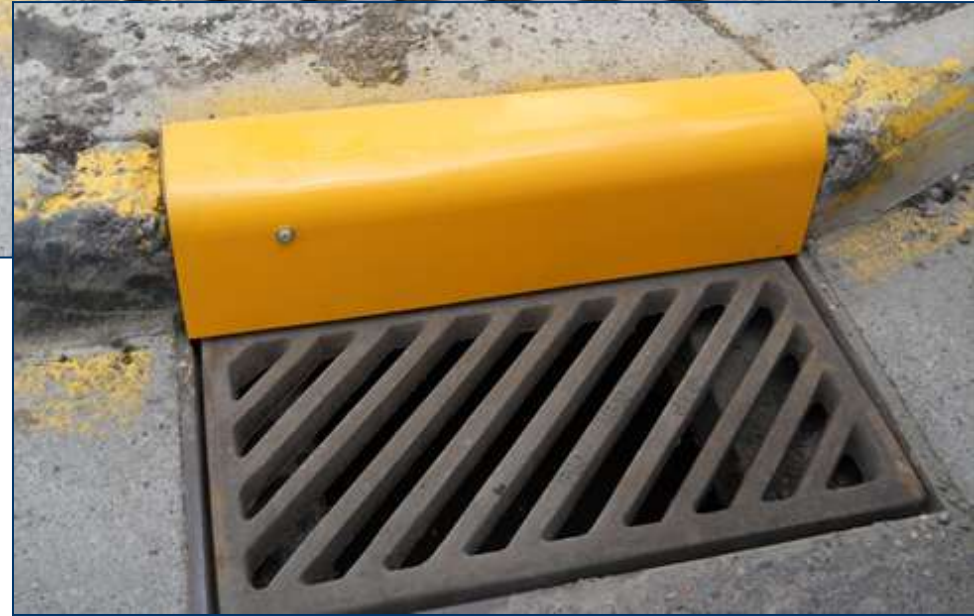
- Removal of concrete and infrastructure took approx 3 days in labor to replace entire backing structure
- A viable solution was to bolt a metal cap onto the remaining infrastructure of the damaged plate

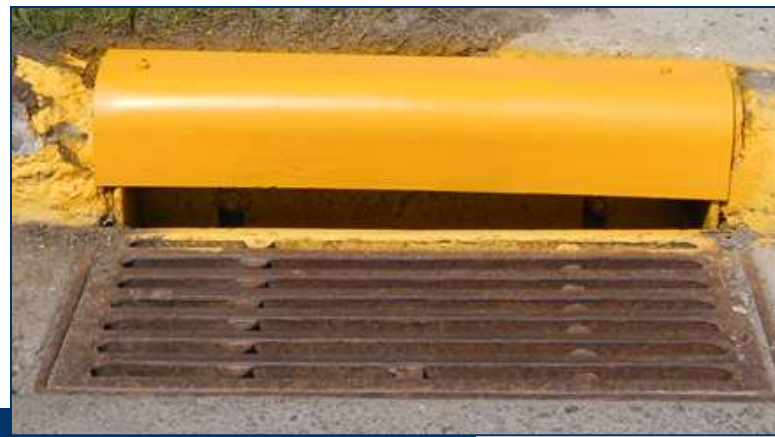
- Shop time to cut and mold cap plate to specific intake plate location + labor to replace plate:
- 1pp @ \$25/hr x 3 hours = \$ 75
- Equipment: Metal Cutter; Metal Folding Equip, Wrench
- Materials: $\frac{3}{16}$ Metal Plate, Bolts, Paint to Match = \$ 25
- **Total Cost: \$100**

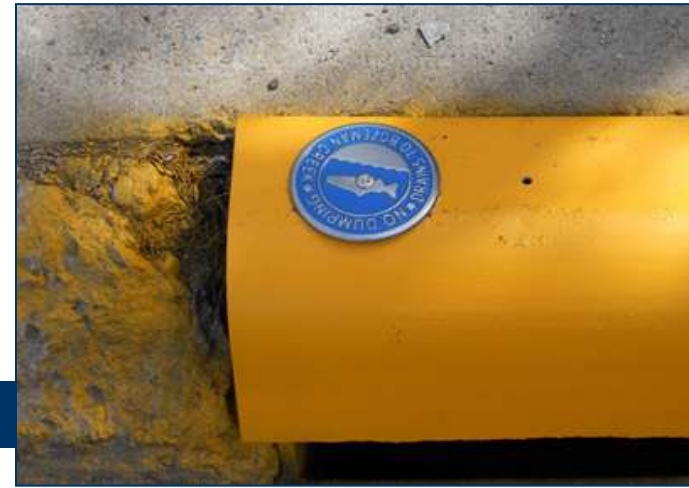
MONTANA: Intake Backing Plate Savings & Benefits

- Less time & materials to repair damaged intake plates
- 3 hours vs. 3 days, for a savings of \$700
- Quicker replacement of damaged plates meets requirement of City's Engineering Dept to protect stormwater drain system
